LID 7

Infrastructure Assessment During Hurricane Harvey Aug 25 – Sep 1, 2017

V 1.12

Apr 25, 2018

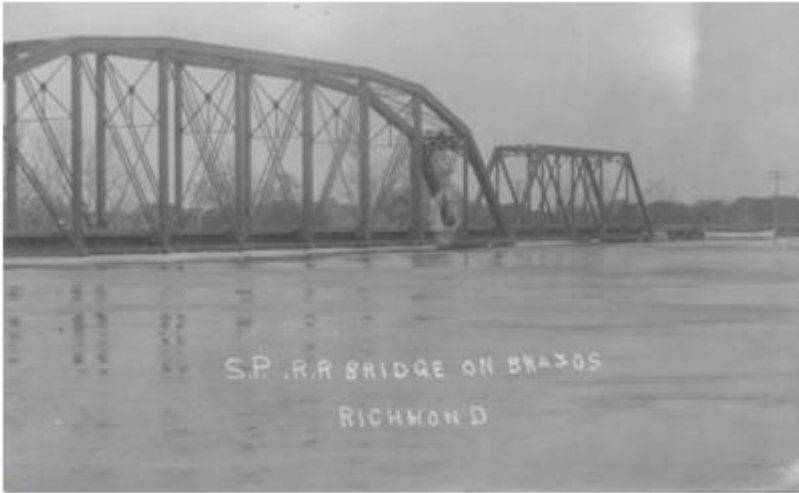
Railroad Bridge at Richmond, 1899 (Crest at 58.6 ft)

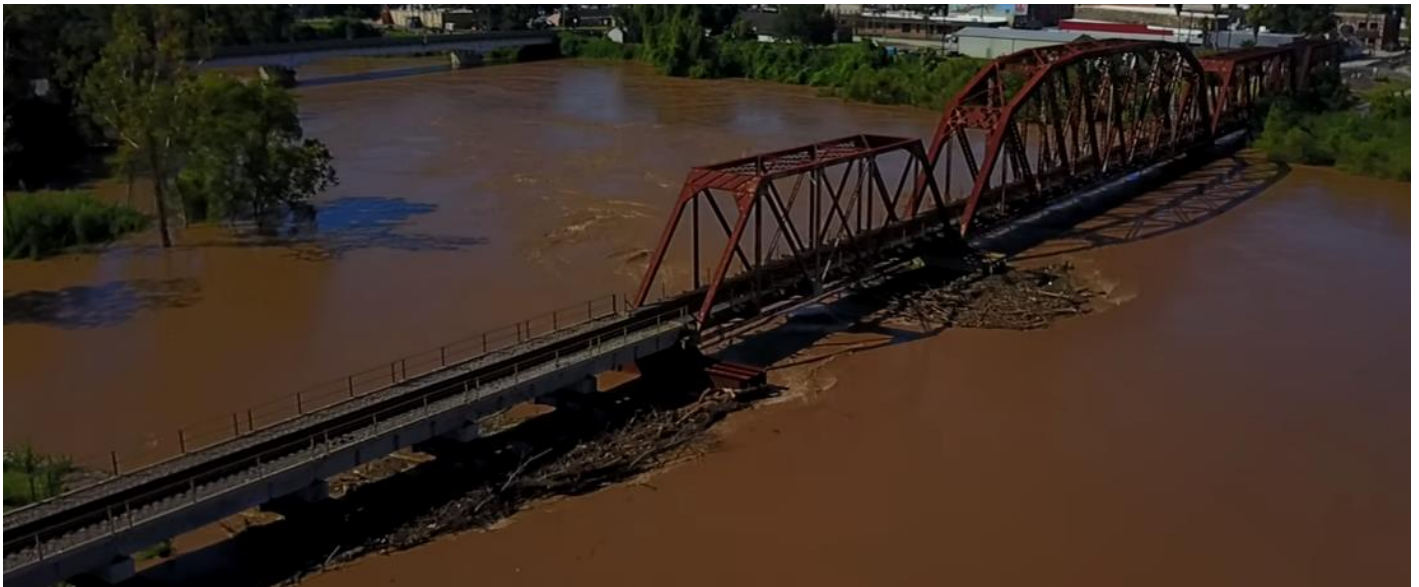
Compare this to the 2017 photo take at a gauge reading of 55.2 ft. The height of the water shown in these photos strongly suggests that the 61.2 ft 1913 flood level was an accurate reading.

Railroad Bridge at Richmond 8-31-2017 (Crest at 55.2 ft)

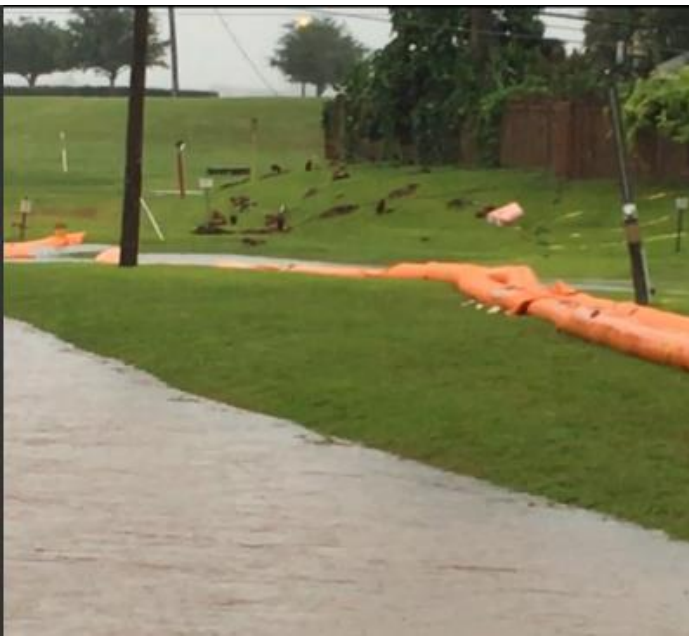
- All water in slough came from rain. Brazos river water did not enter slough.
- The initial effort to place tiger dams failed (photo #1). A small tornado was identified as a possible reason, though it is also possible that moving water from Robinsons Landing neighborhood behind levee caused the failure. A subsequent effort successfully placed a 3-tube dam.

- Tiger dams were ineffective. The added height provided no protection to the school or the businesses. They also appear susceptible to fast moving water.
- Flood waters threatening the Commercial Tract businesses came from the section between 90A and the school bridge (where no dams were placed).
- The railroad track creates a constriction point which regulates the volume of water reaching Bullhead slough south of 90A. It is possible that higher rainfalls would simply result in increased water levels north of 90A, while flow rates south of the track would be relatively unchanged.

Failed tiger dams (1st attempt)

- Build an earthen berm/flood running from either:
 - the corner house (Robinsons Landing) to 90A.
 - the Telfair levee to 90A.
 - elevation should equal the height of the railroad tracks plus one ft.
- Deepen Bull Head Slough channel to Ditch H.

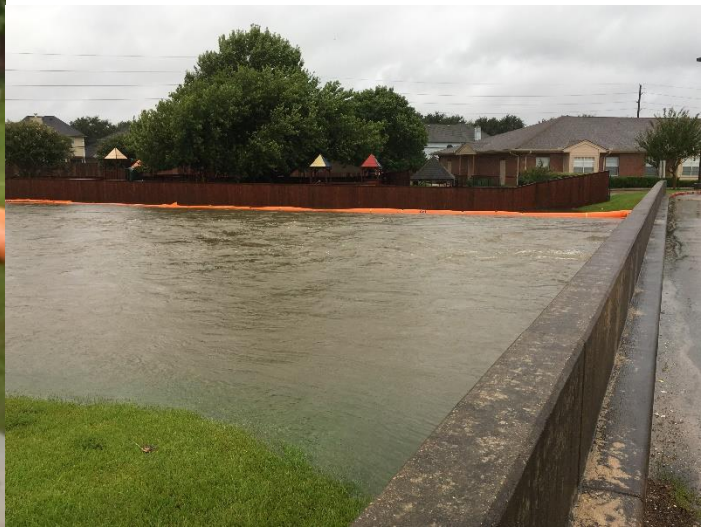
Reset tiger dams - Tue AM (8-29)

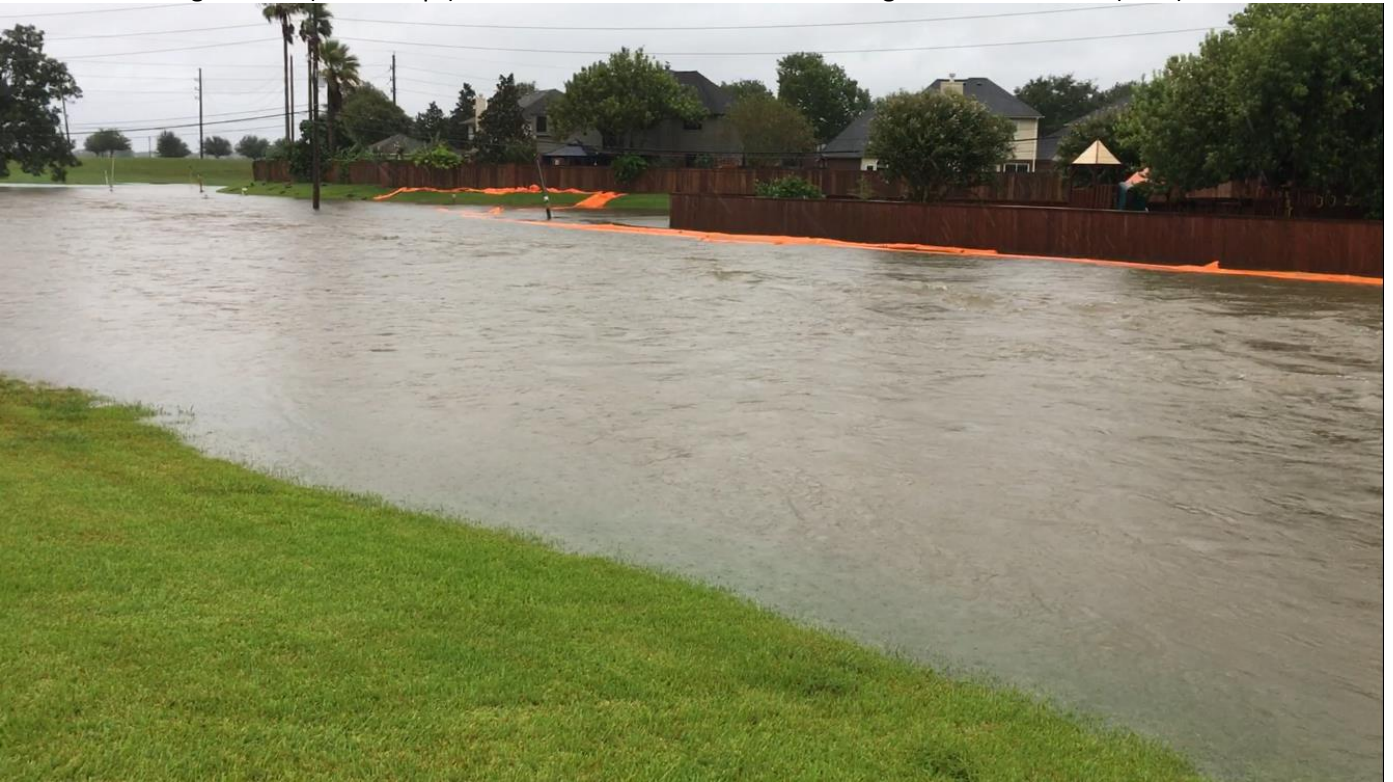
Commercial tract tiger dams at rain sourced high water – (Tue AM 8-29)

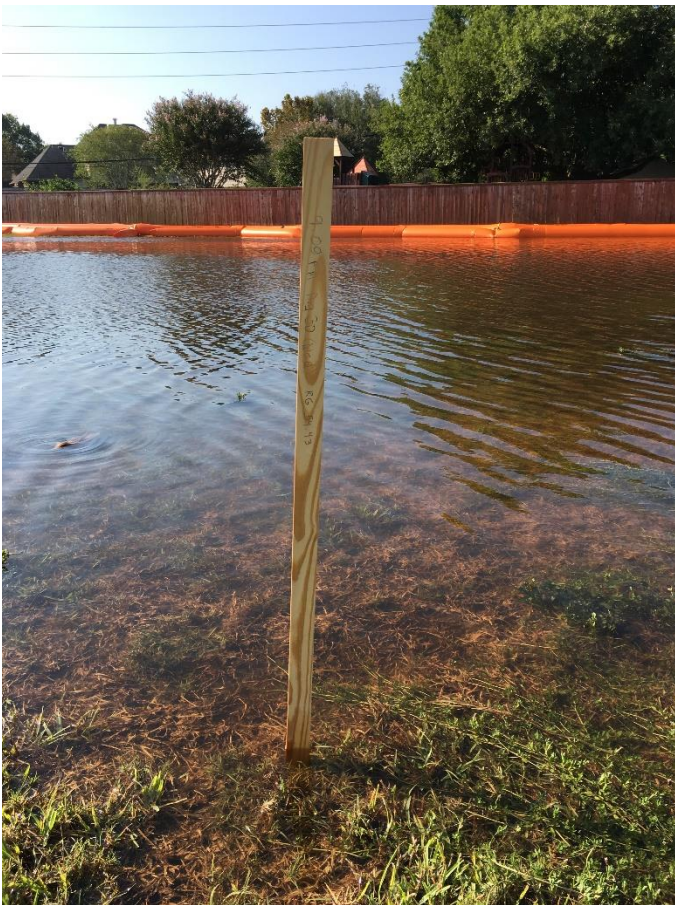
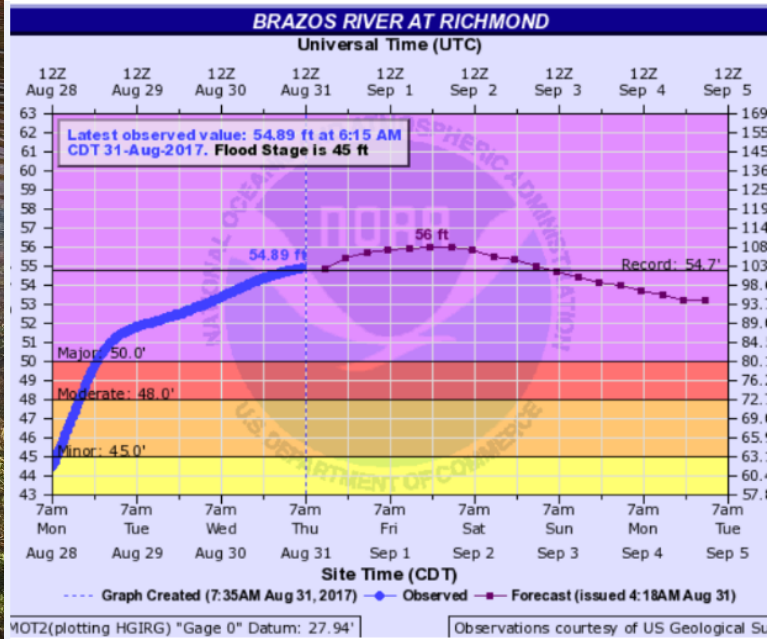
Commercial tract at (near) Brazos high water mark (Aug 31)

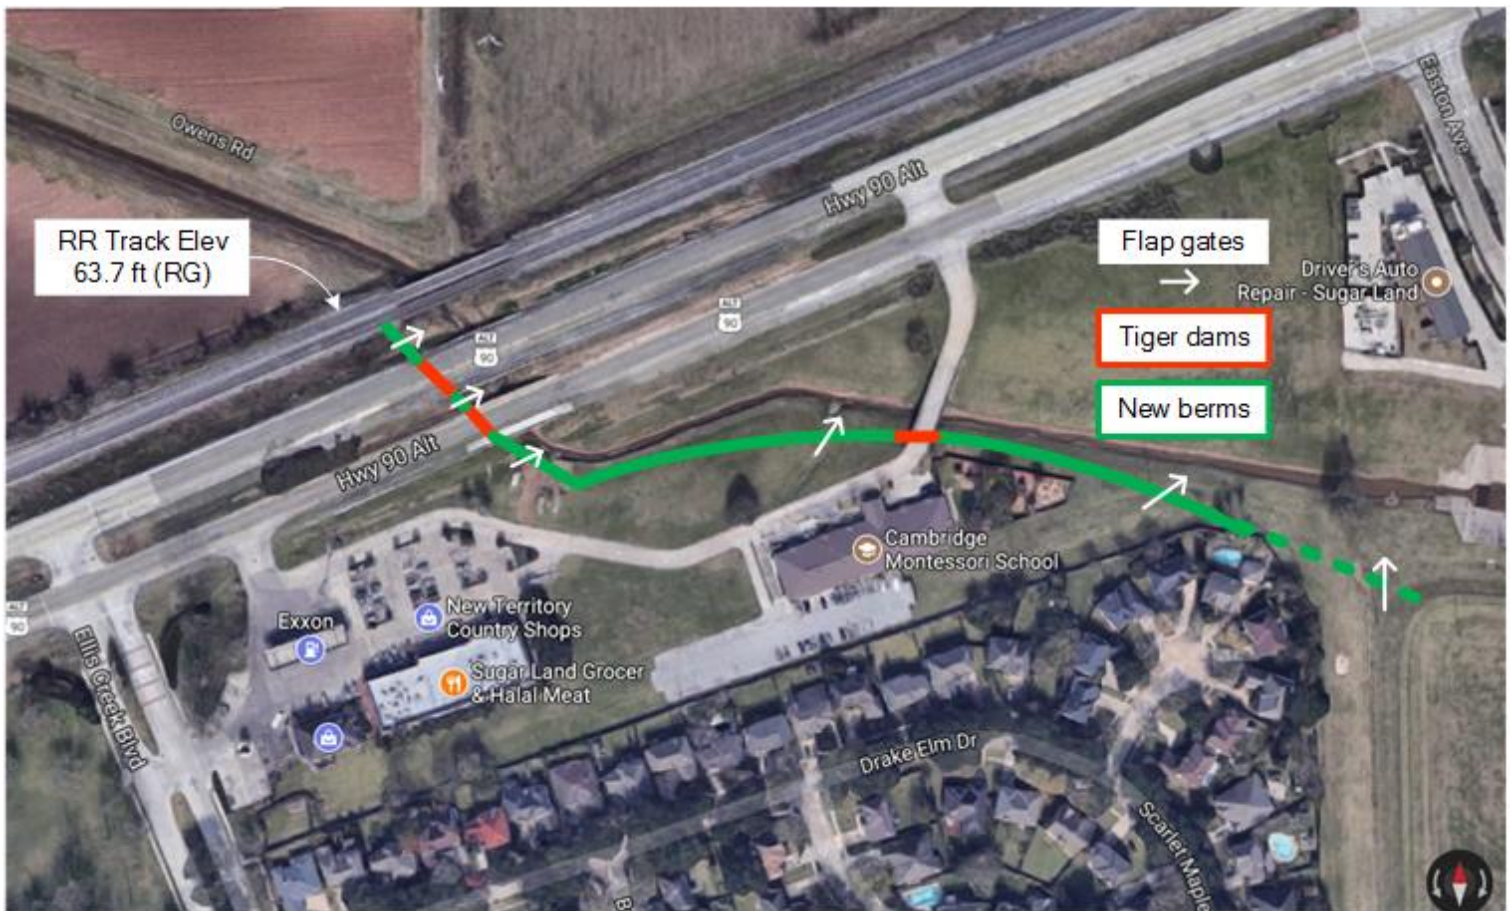
Proposed New Berms

Laser level used to measure 8.5 ft elevation difference between Harvey HWM (55.2 ft) and track bed (63.7 ft).

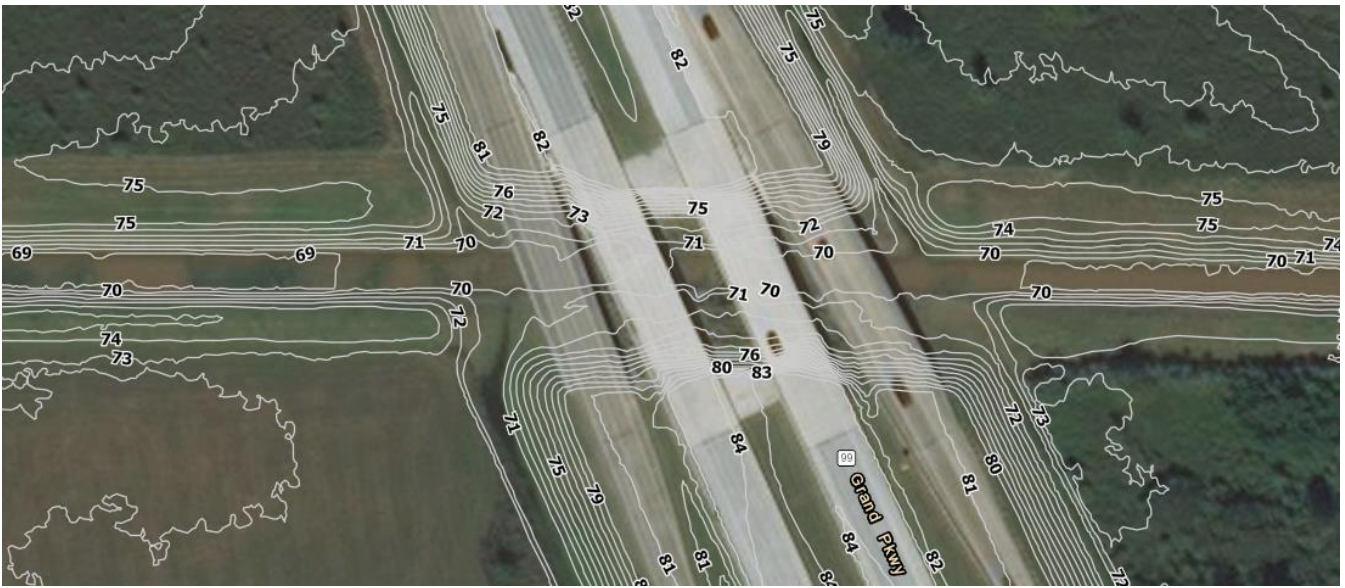
Bullhead slough over tops its south bank, at 99, at an elevation of 70 ft.

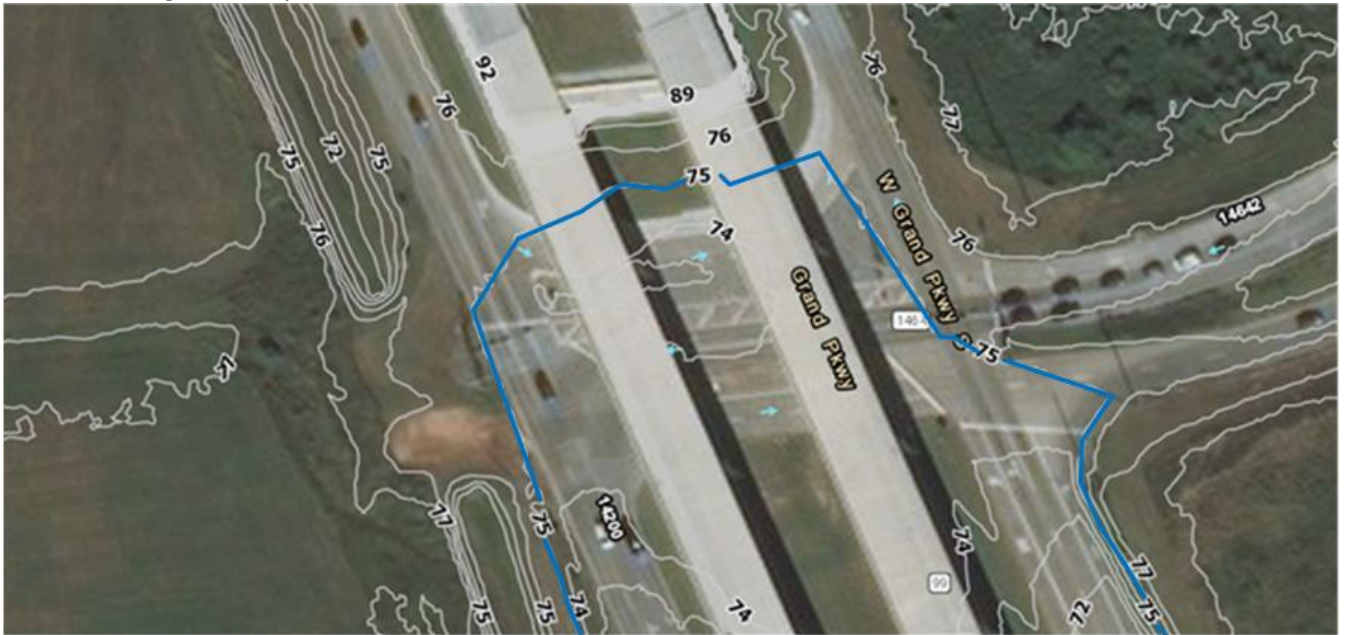
Traveling south, the southern bank peaks at 75 ft.

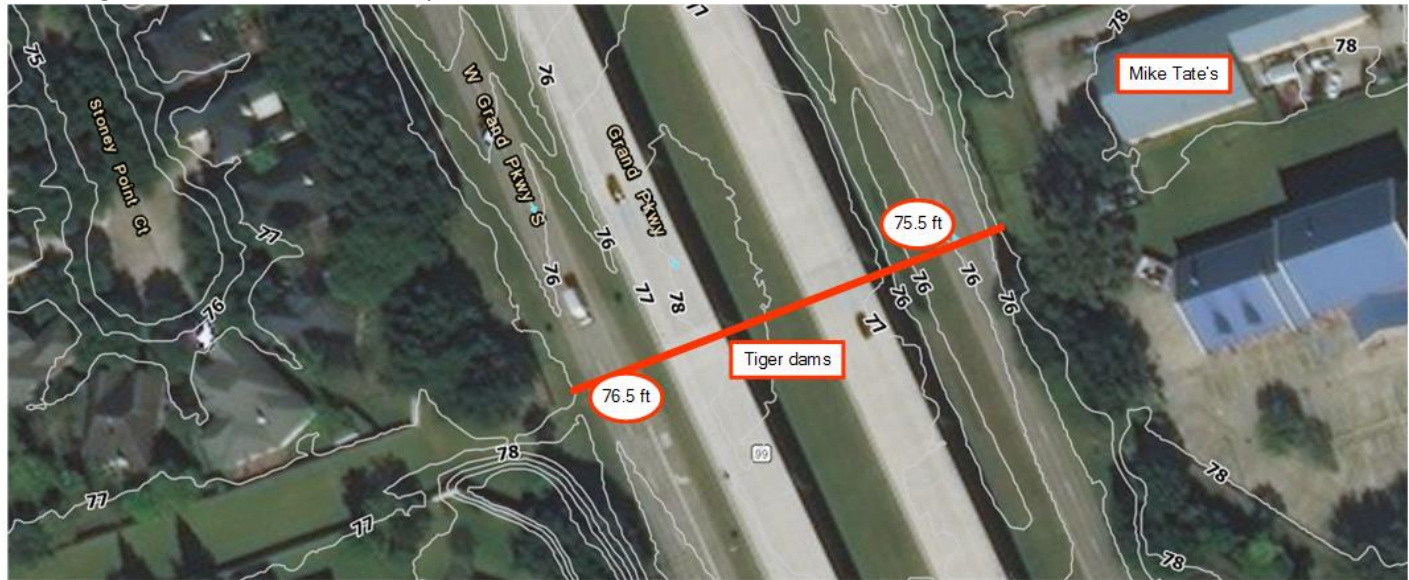
Max rain water height reached 76.5 ft at tiger dams.

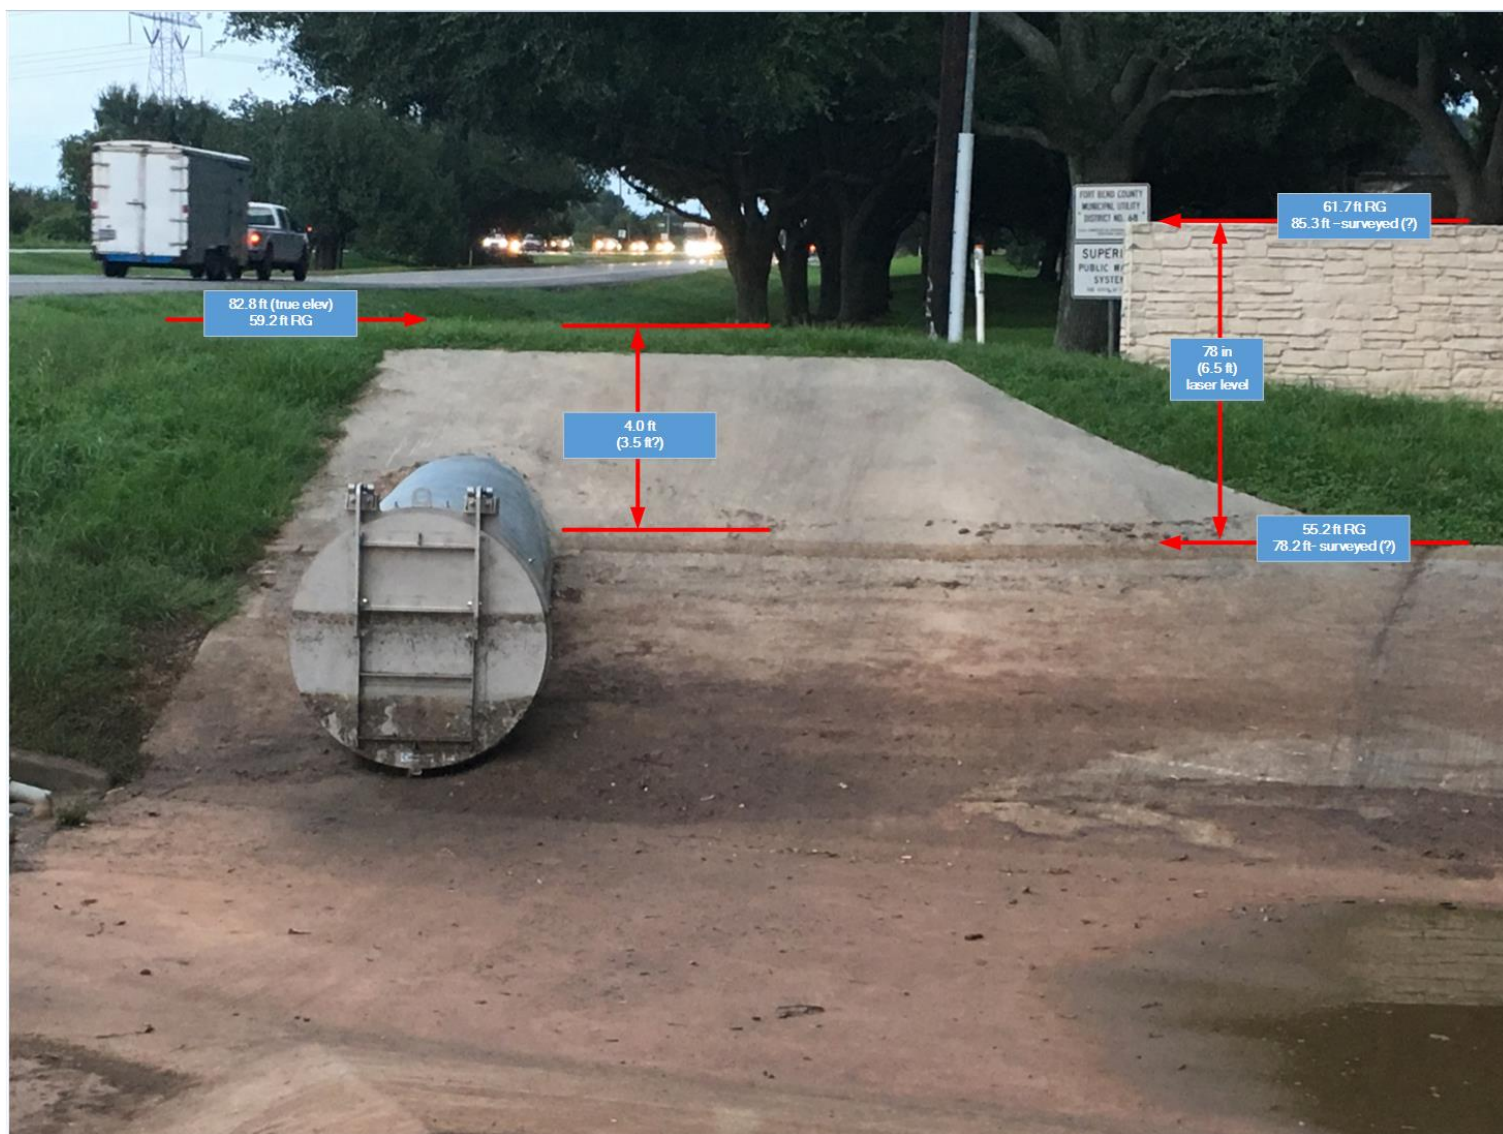
- Highest Brazos river levels reached (RG 55.2 ft.).
- LID 7 levee at 90A/external channel maintained 43 in. freeboard at max water level.
- 90A east bound flooded and was closed. 90A west bound remained open during event.
- HWM analysis indicates railroad tracks at NW corner of LID 7 protect to a height of 60.8 ft.

External Channel at 90A (Brazos river high water mark)

- Add flap gate closed between RR track on 90A west bound to eliminate need for tiger dam.
- Railroad tracks provide effective flood protection to between 59.5 – 60.0 ft. The provide additional production up to 60.8 ft. Top foot of railroad track bed is subjected to seepage, but this should be controllable with adequate pumpage.

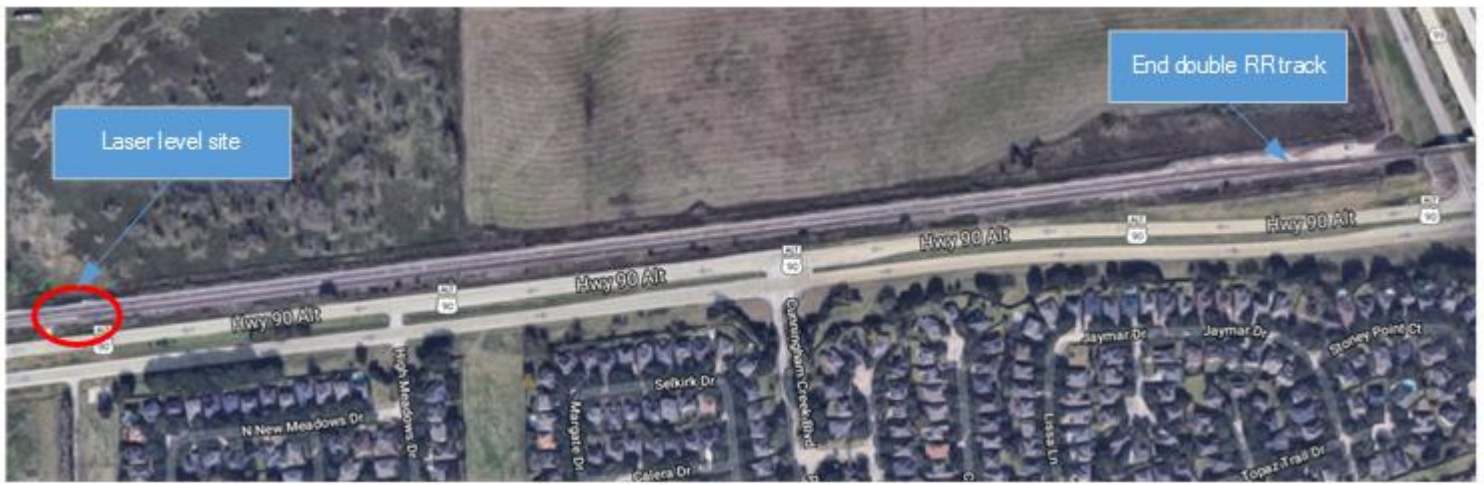
Laser level elevations (Richmond Gauge basis)	Description
55.2 ft	Brazos High Water Mark (HWM)
61.7 ft	Top of flood wall
59.8 ft	Top of RR track bed

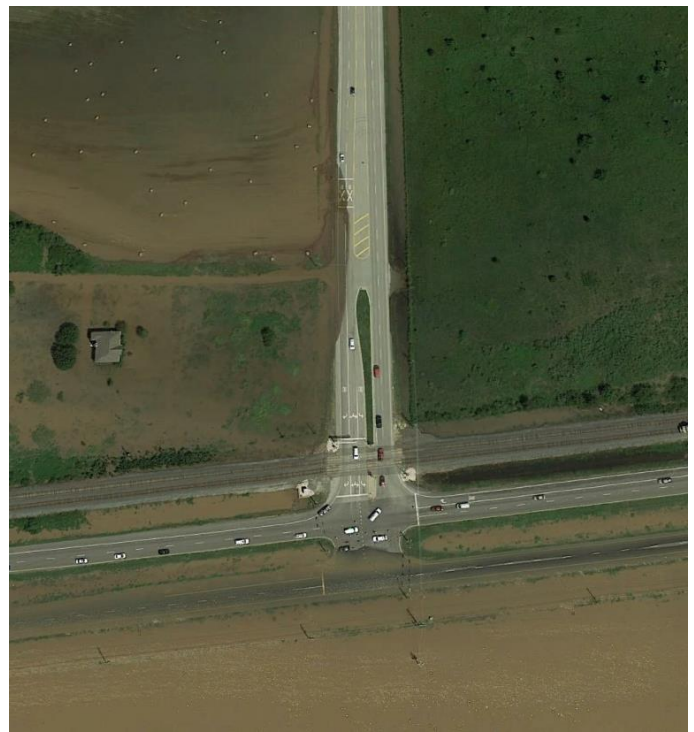
90A & Harlem 8-31-17 (elev 79 ft at cross over)

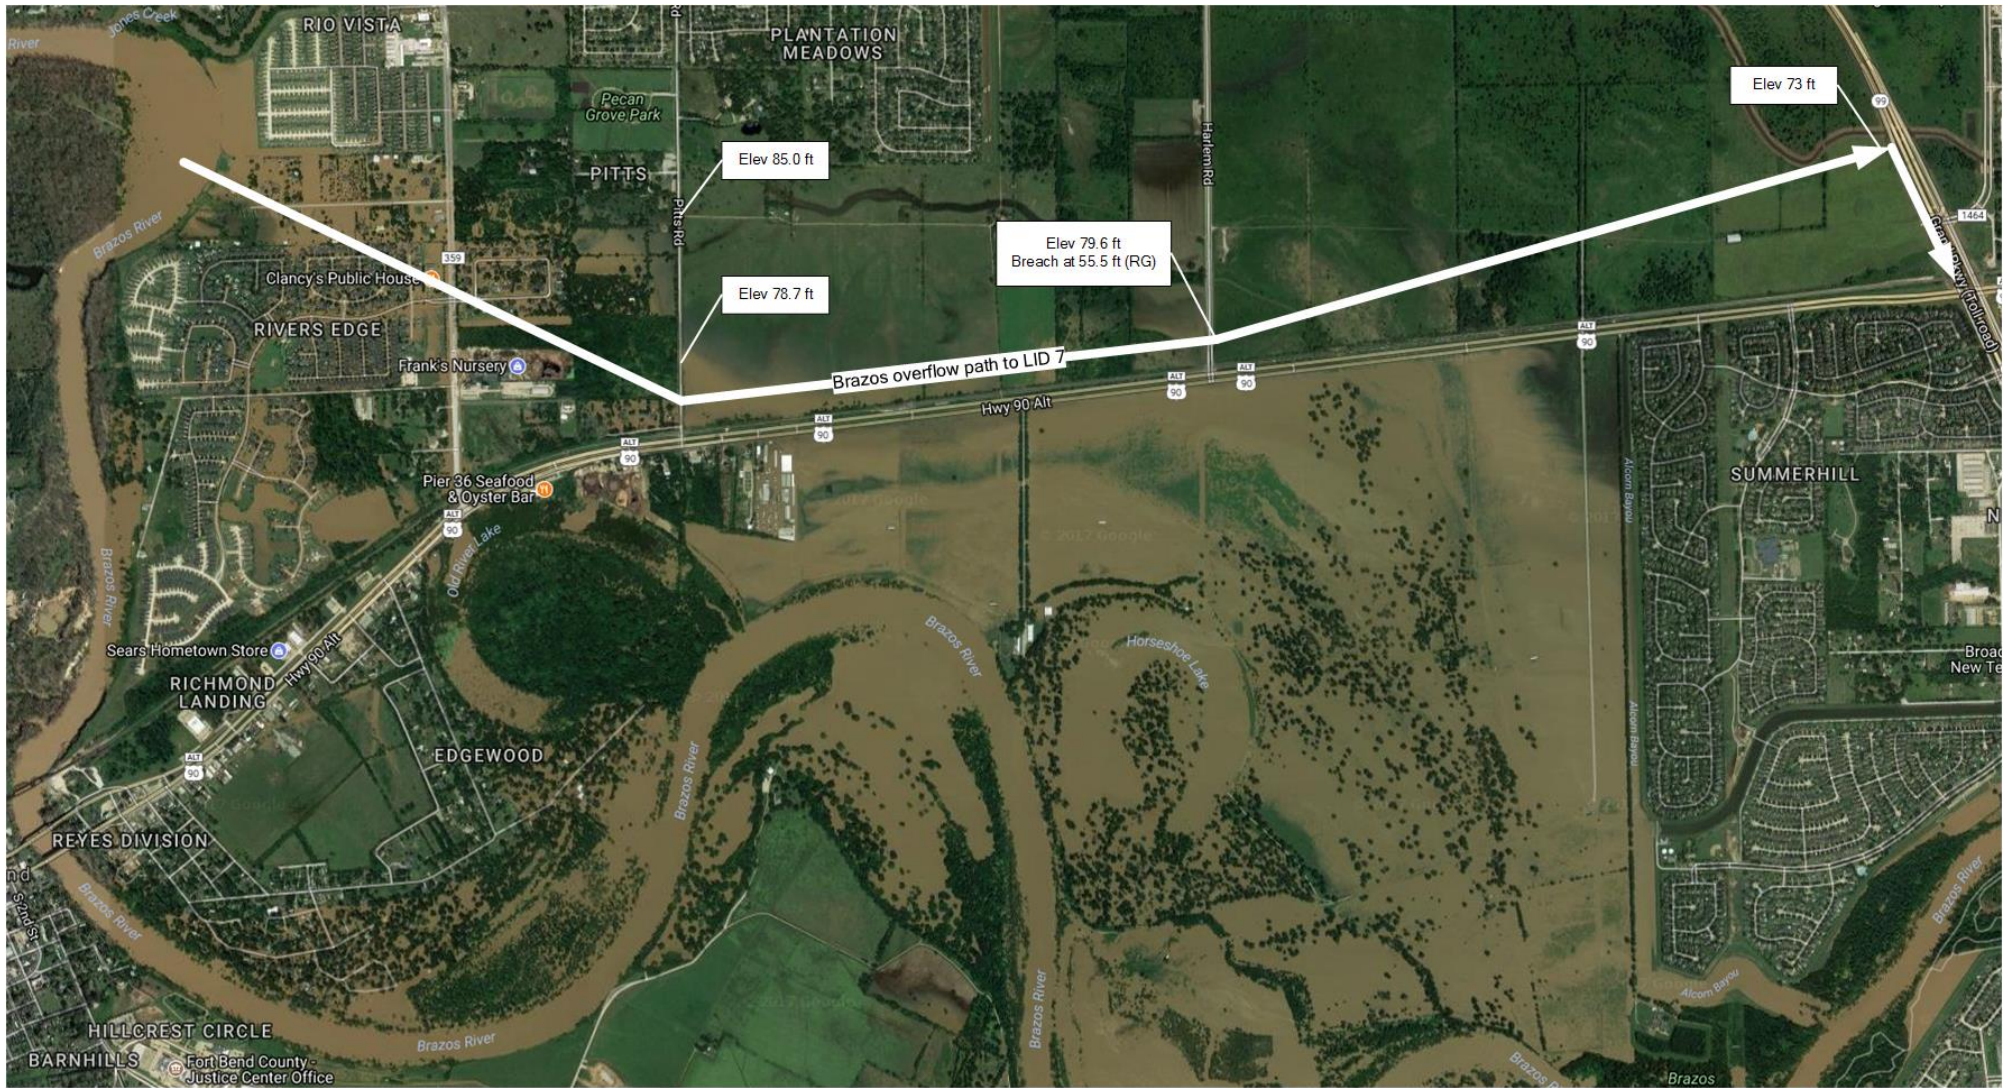
A levee connecting the higher fill in Rivers Edge behind Rio Vista and to Pecan Lakes does physically cut-off the overflow for a 100-year event. This would not provide the additional freeboard to be certified by FEMA. The extended levee in the PER connecting to Pecan Grove would be a FEMA certifiable levee with plus 4 feet of freeboard.

Brazos river overflow path from Rivers Edge/Rio Vista to LID 7

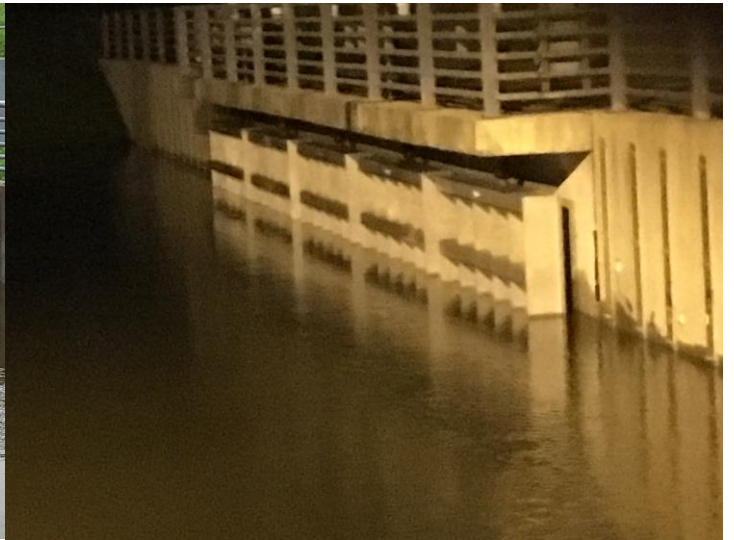
- Pump station water level down about 12 in.
- All four pumps (25,000 GPH) ran for at least 7 hours, but eventually they tripped and went off line. Operators waited 20 minutes and then brought up 2 pumps. They continue to rotate running 2 pumps at a time.
- Power was never lost at the pump station.

Dropped water levels – Wed 8-30 5:30 AM
(16 hr 45 min of pumping – approx. 12 in.)

- Perform following pump station upgrades are recommended in Schrader study. Including,
 - Update wiring so that all 4 pumps can be run by generator. There still may be a restriction that only 3 pumps can run concurrently by generator.
 - Resolve issues preventing all four pumps from running simultaneously using grid power.
 - Install solid state control system.
- Build second pump station to increase capacity.
- Replace/refurbish existing station to increase capacity to approximately 300,000 GPM.

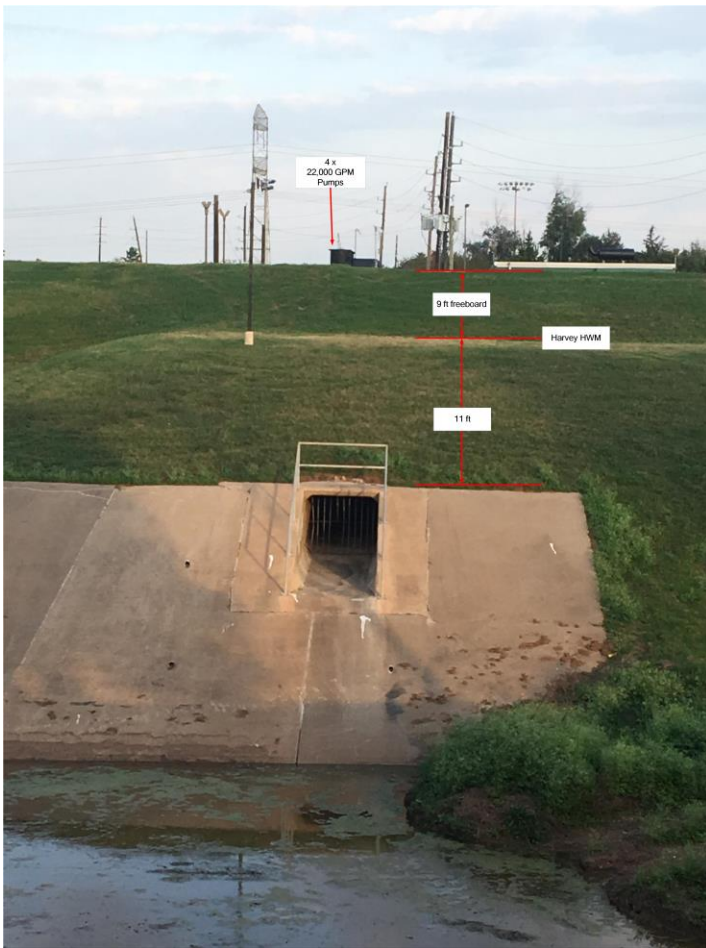
Pump outflow culvert was approximately 11 ft under water at the Harvey HWM.

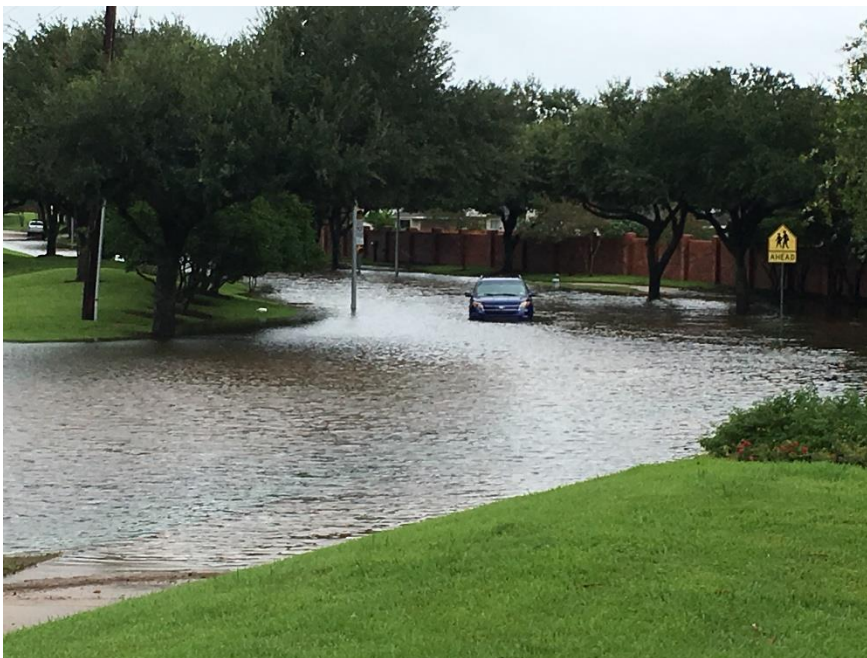
Chapel Bend entrance – Tue 8/29 11:00 AM

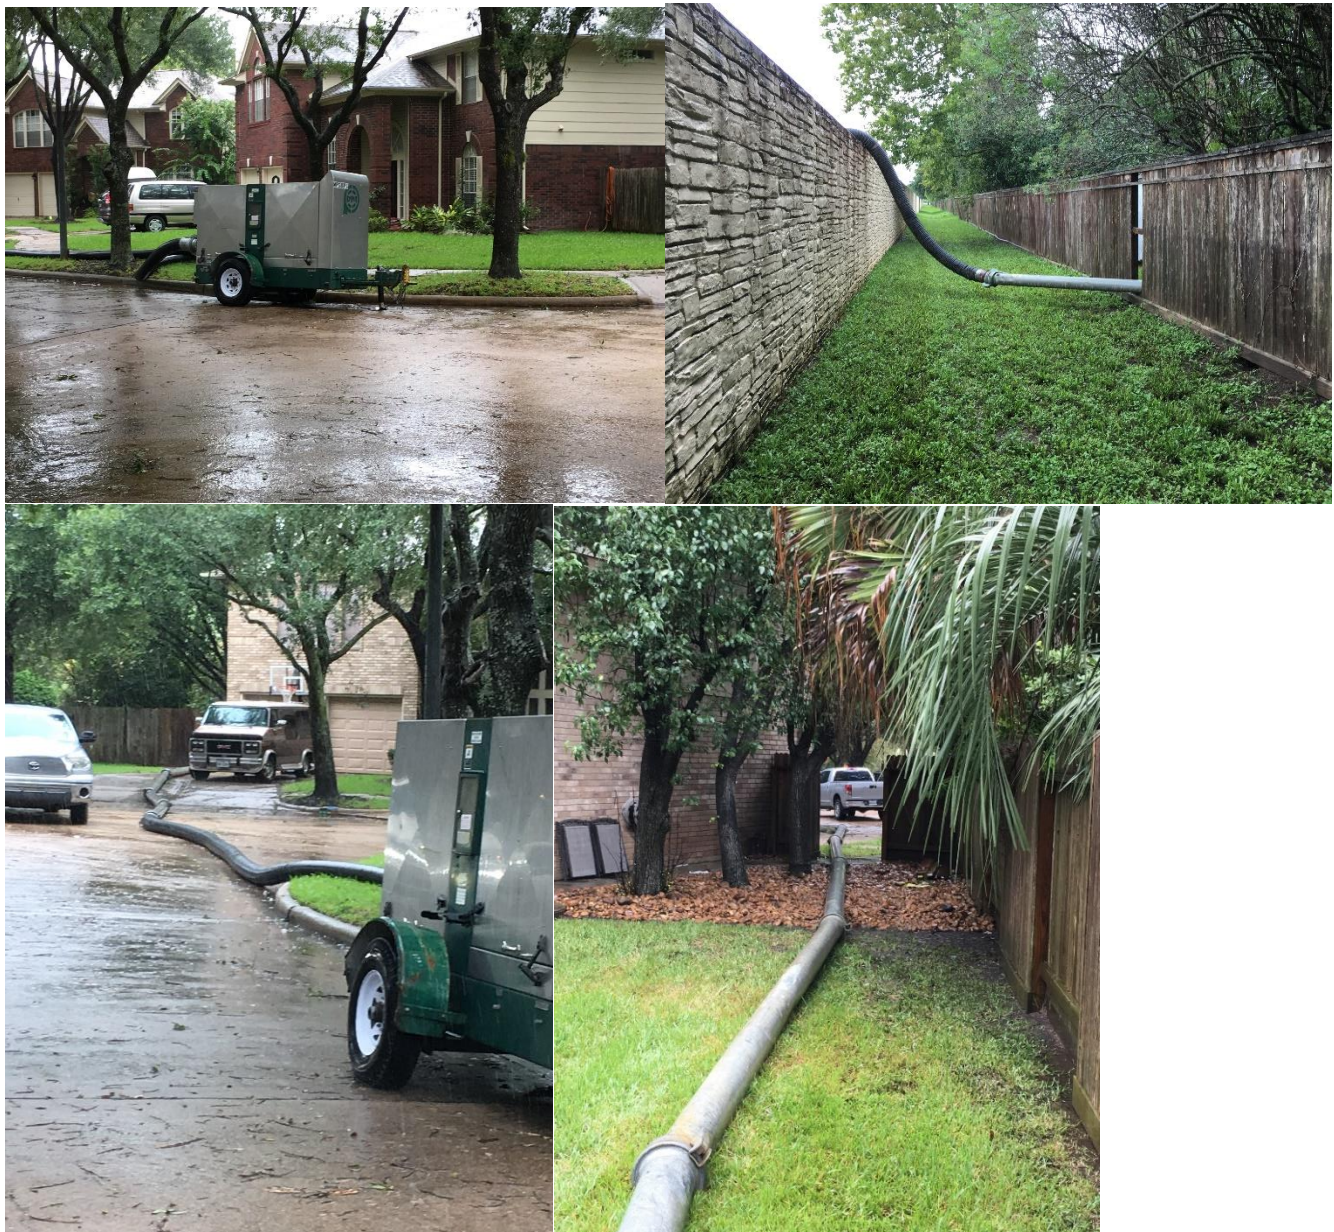
- Cunningham Creek / Sandhill intersection dry.
- Two portable pumps set up. One in High Meadows and the other in Autumn Ridge.
- Both pumps rated at 4,000 GPM.
- Streets mostly dry throughout neighborhoods.
- Autumn Ridge portable pump shut off to conserve fuel. Street still passable, but water is high at pump.

High Meadows portable pump – Tue 8-29 noon

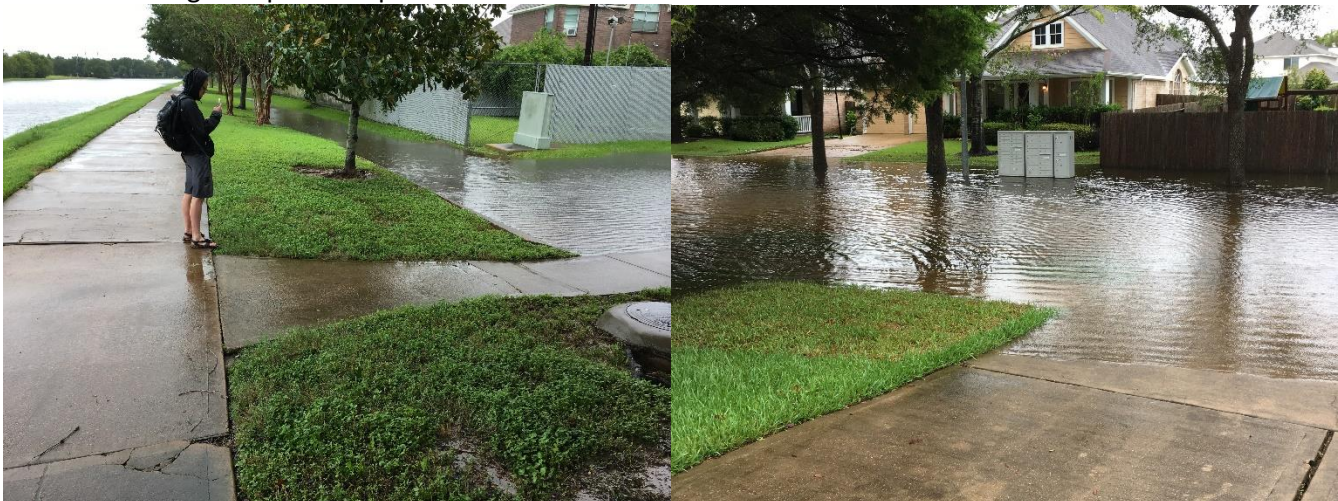
River Glen at Ellis Creek lift station – Tue 8-29 11:30AM and just inside neighborhood

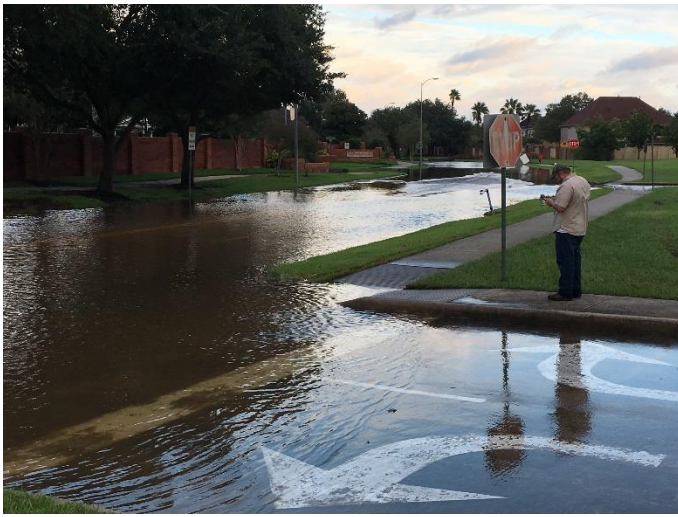
Homeward Way at Sartartia MS – Tue 7:30 PM

- See 4.1 Pump Station improvements.
- See 5.3 Drainage Map.
- See 7 Optional Detention Capacity.
- See 10.4 LIDAR Map LID 7
- Consider sluice gates and backflow preventers at the Greystone lake culvert.

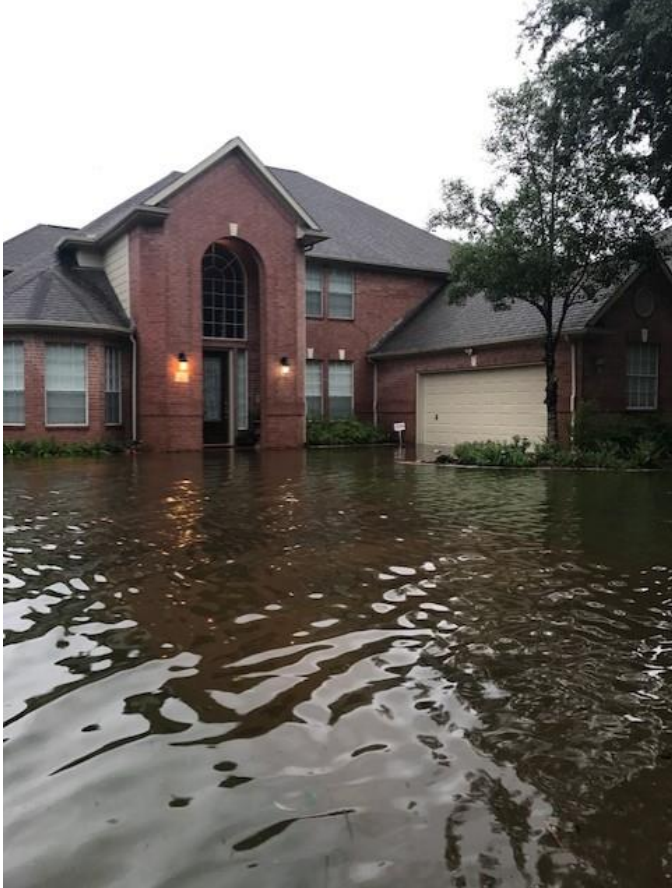
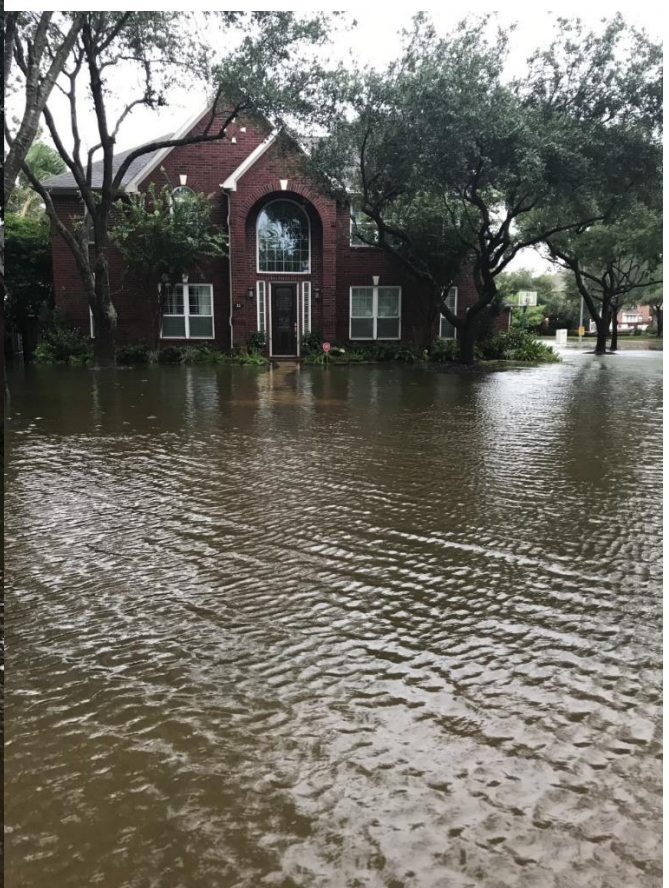
8 Amberstone Dr. (did not flood)

11 Amberstone Dr. (did not flood)

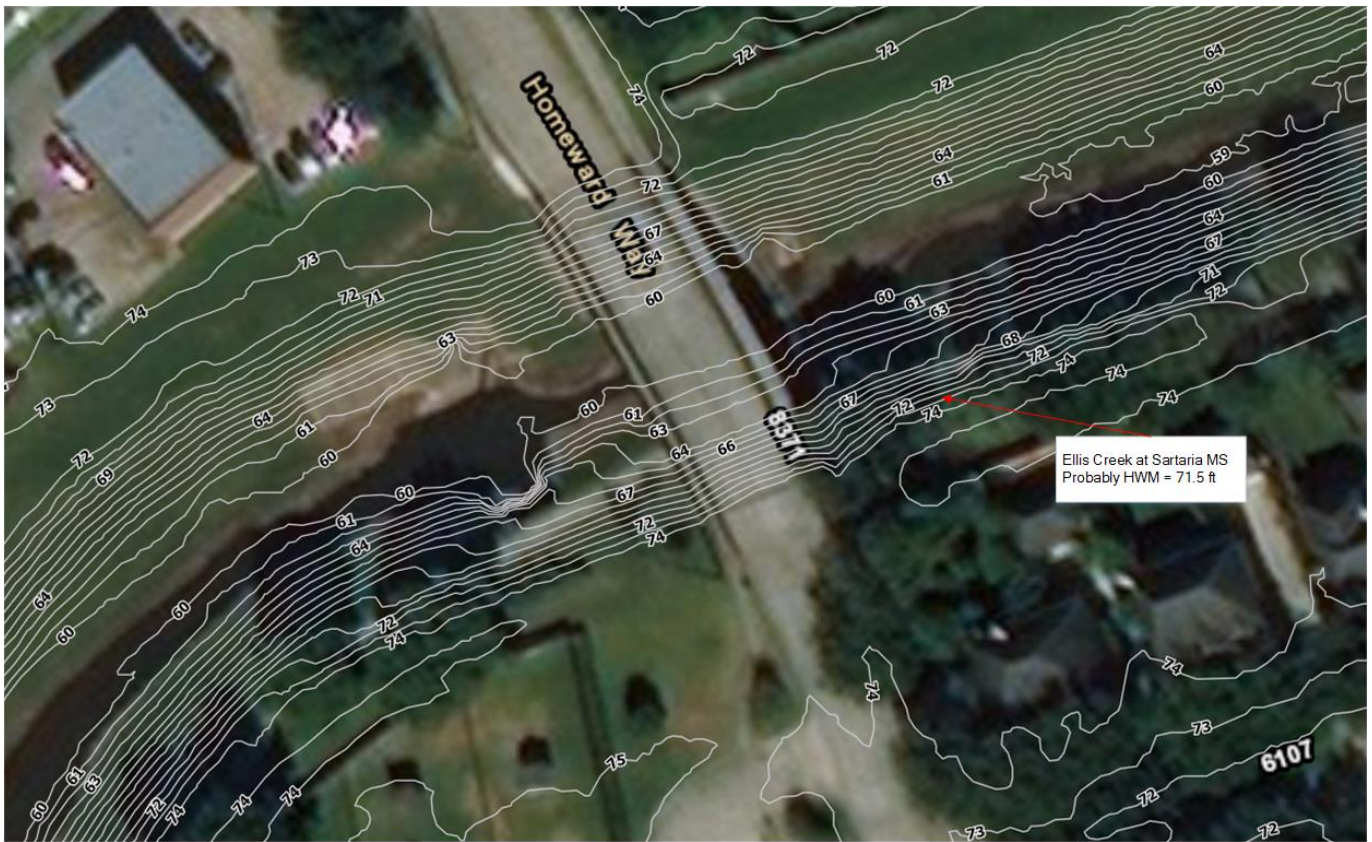
Ellis Creek high water mark (HWM) is unknown. Anecdotal reports indicate that it did not overflow its banks. No photos are available. A HWM of 71.5 ft is consistent with the water level in Greystone.

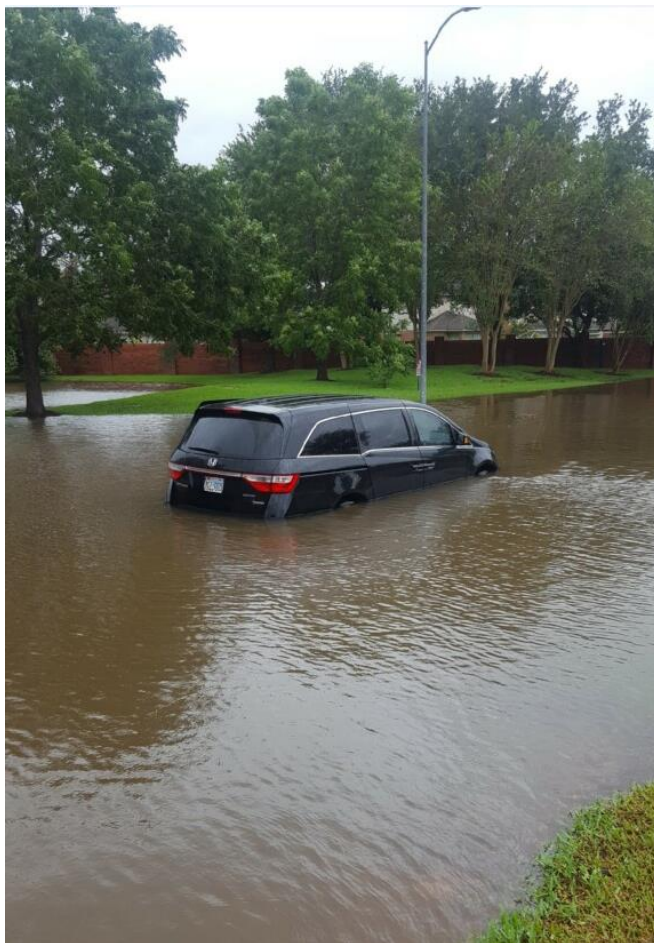
Lower edge of Lakewind lake on Homeward Way.
(LIDAR elev of street at blue car = 71.0 ft) (Tue 8/29/2017)

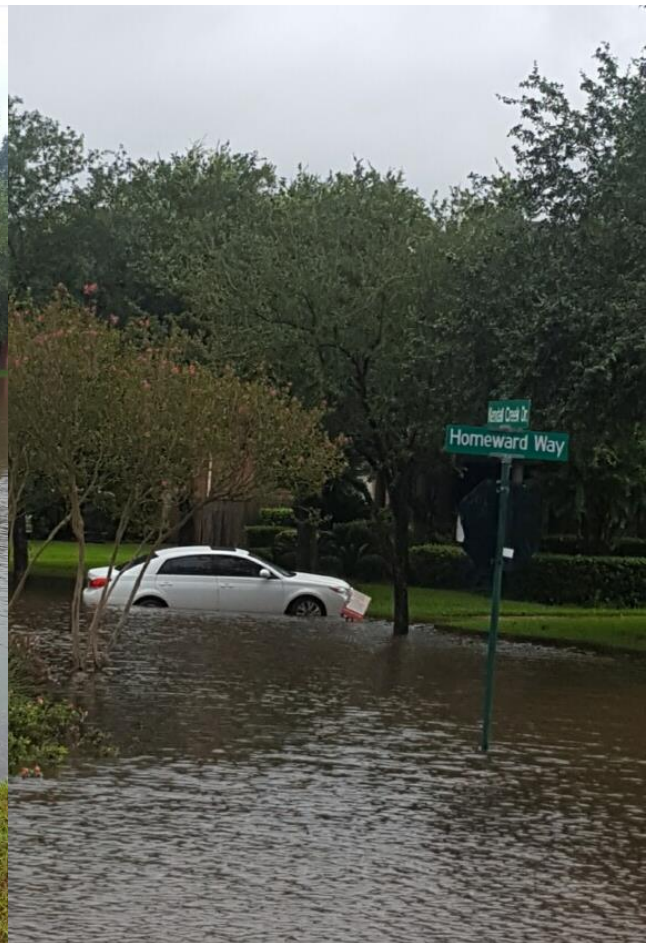
Kendall Creek at Homeward Way. (see drainage map)
(LIDAR elev of sidewalk = 72.0 ft) (Tue 8/29/2017)

LIDAR elevation of Watermill drain, adjacent to Kendall Creek, 72.0 ft.
