LID 7

Infrastructure Assessment During Hurricane Harvey Aug 25 – Sep 1, 2017

V 1.12

Apr 25, 2018

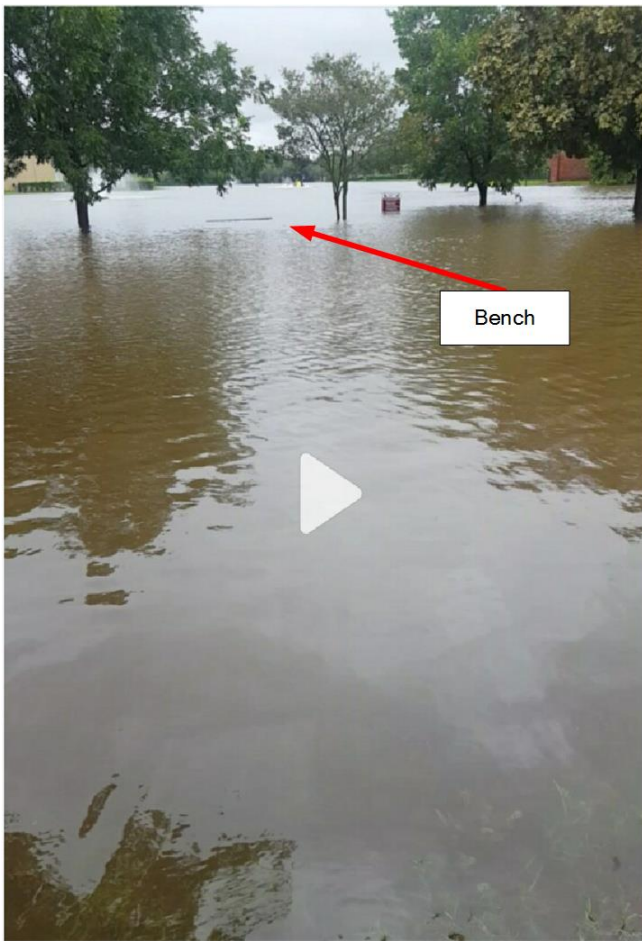
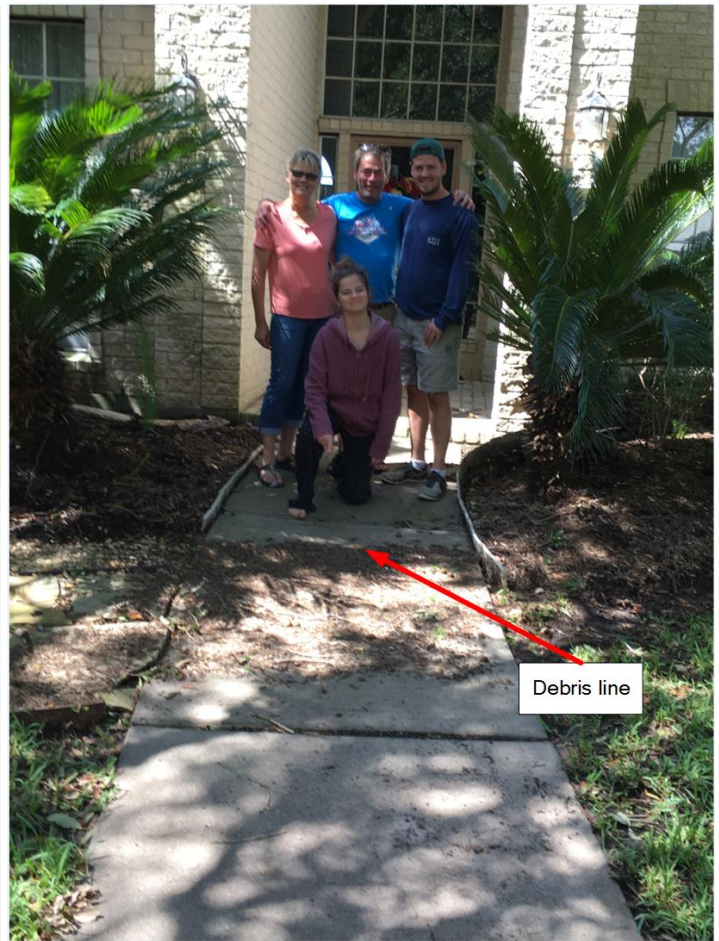
- A. View of Lakewind lake from Homeward Way. Horizontal line, between two trees, is top of bench.
 B. **Debris line** marks max water level (Lakewind house backing up to lake) -Thu 8-31 10:00 AM

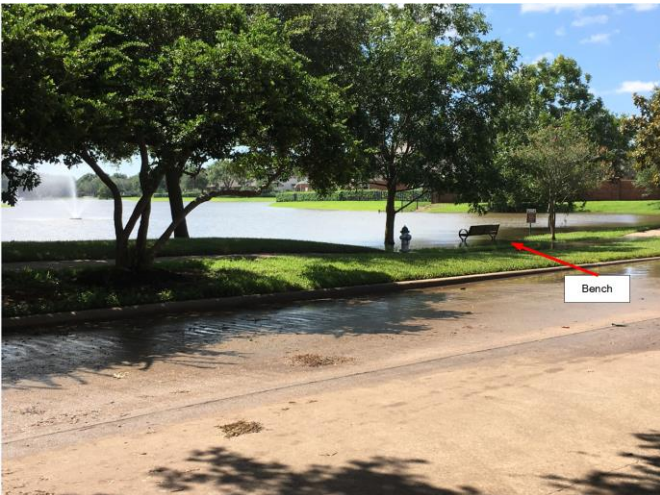
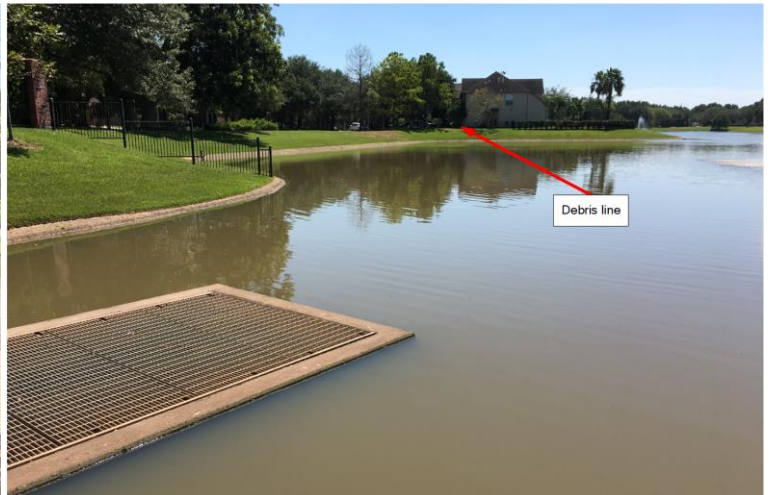
- A. Lakewind bench (normal conditions) – (LIDAR elev at bench = 70.5 ft)
 B. Lakewind home with debris line (note drain).

The Harvey high water mark (HWM) at the Lake Wind bench is approximately 1.5 ft. above the inlet drain to the Greystone / Watermill drainage system. This indicates significant amounts of water migrated into the Greystone area from Lakewind. This is a possible cause for home flooding. While it is probable that Ellis Creek water did flow back in the Greystone lakes, the elevation of the Ellis Creek waters may not have been high enough to reach home levels.

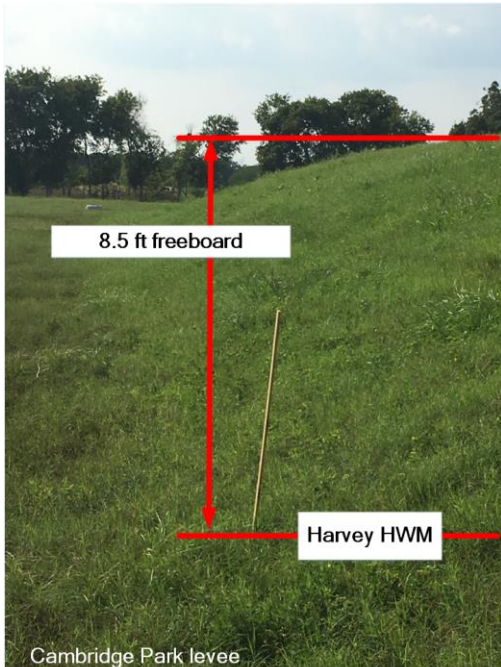
Cambridge Park high water mark

- Assess options for raising barrier at 90A.

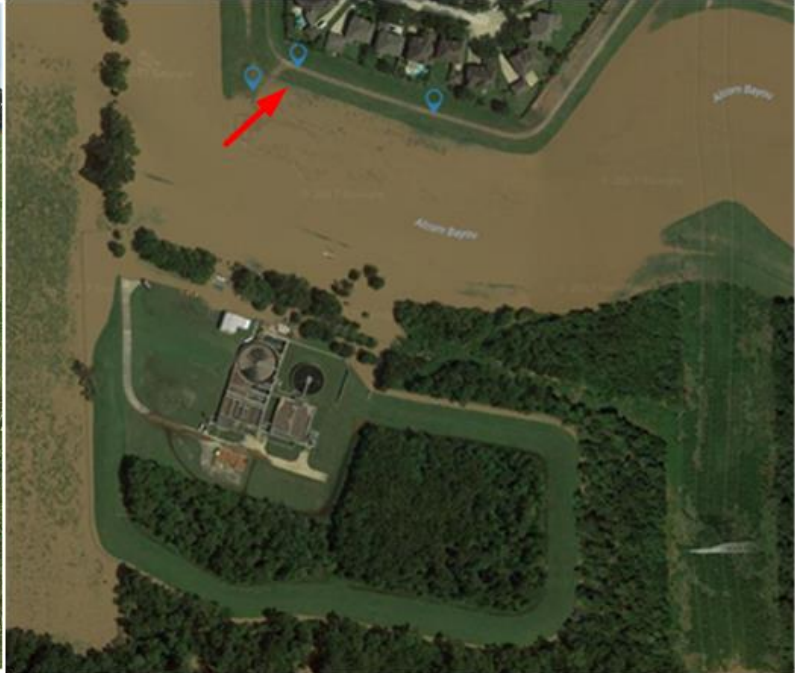
MUD 112 WWTP (Aug 31, 2017)

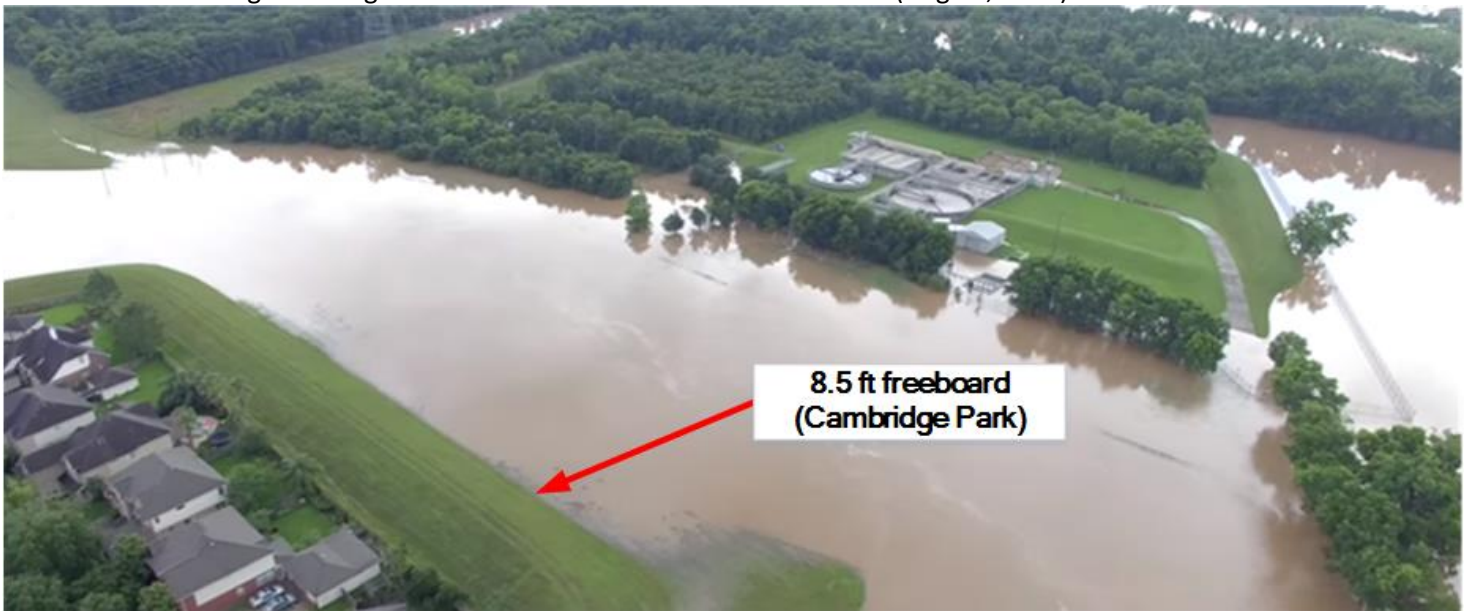
MUD 112 WWTP (Jun 2016 – Memorial Day flood)
