LID 7

Infrastructure Assessment During Hurricane Harvey Aug 25 – Sep 1, 2017

V 1.12

Apr 25, 2018

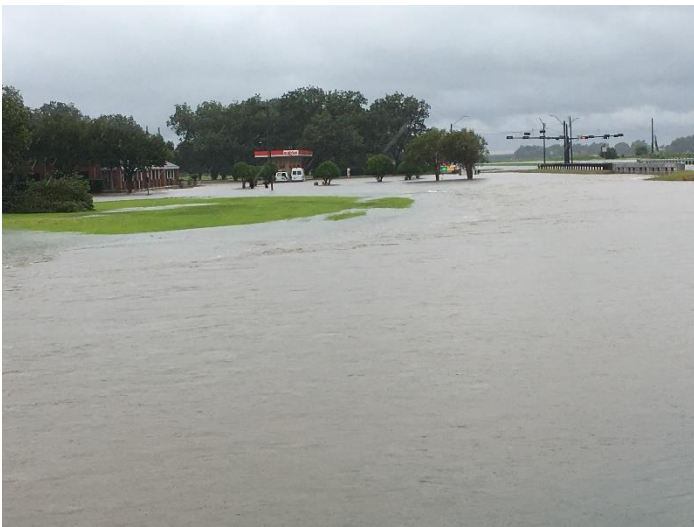
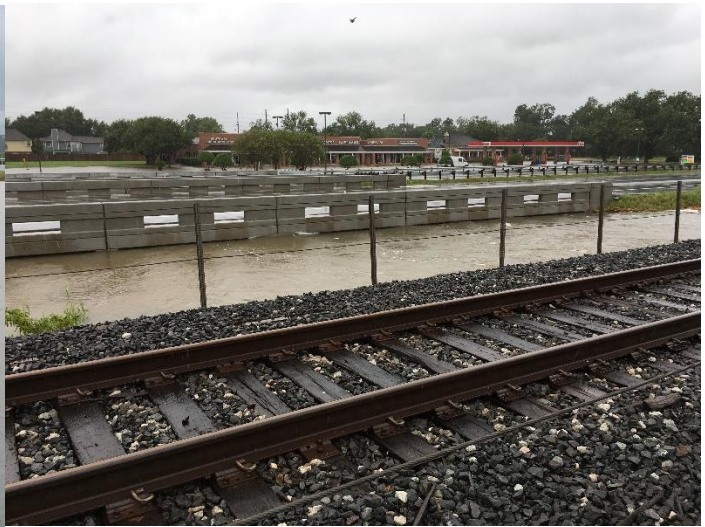
View West from school bridge - Tue AM (8-29)

View South showing 90A & Commercial Tract

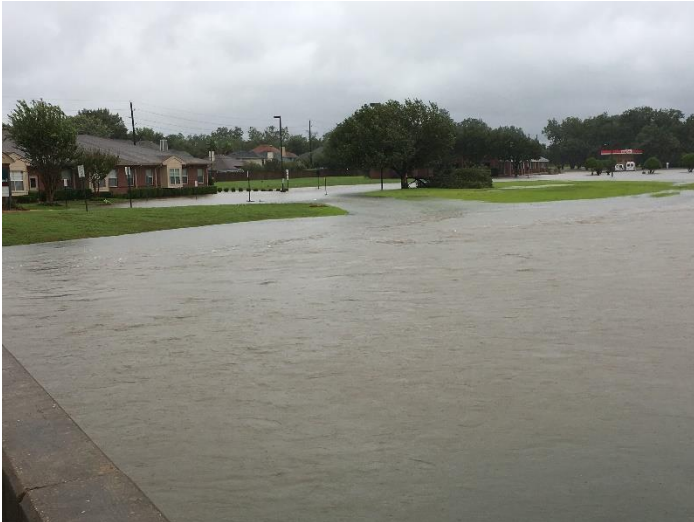
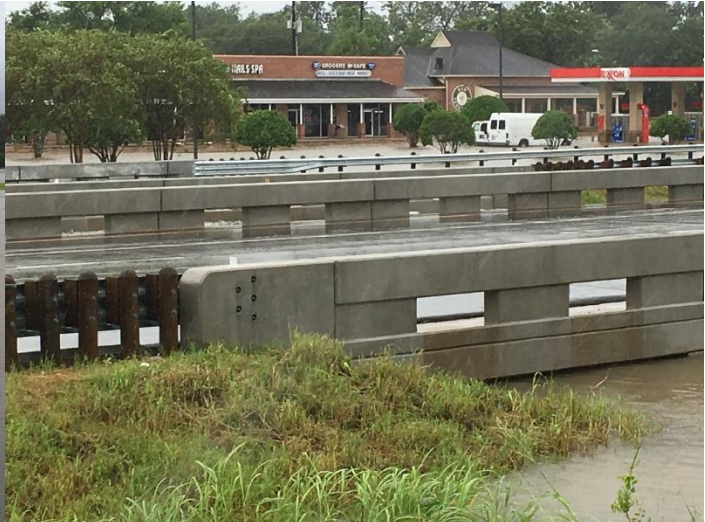
View of school from school bridge - Tue AM (8-29)

View South showing 90A & Commercial Tract

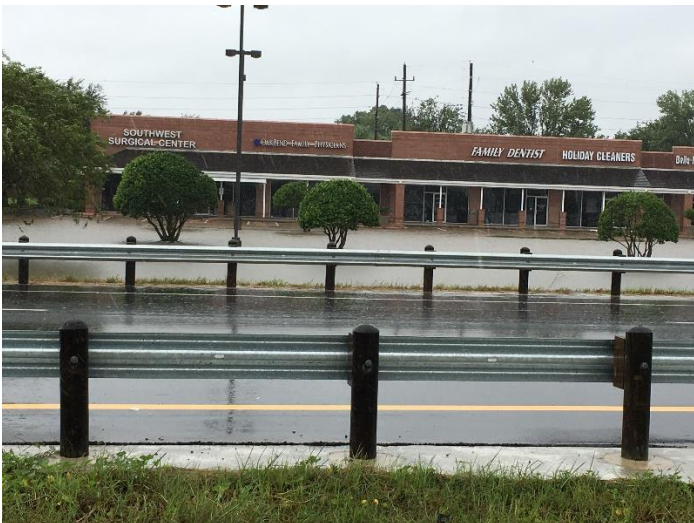
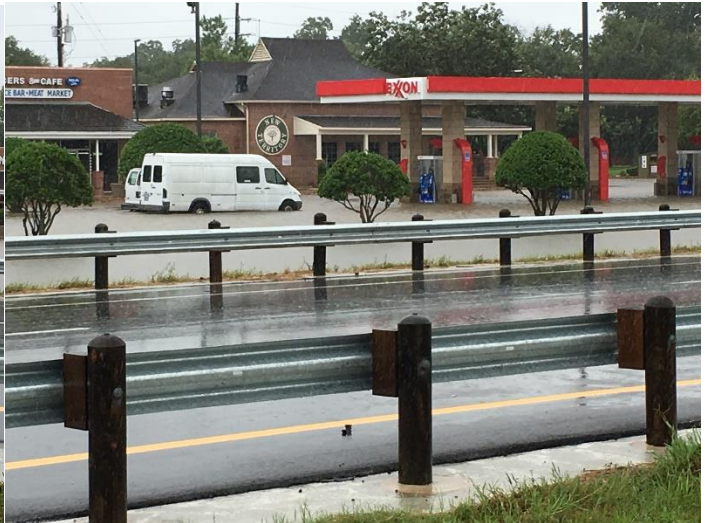
View of Commercial Tract south from 90A - Tue AM (8-29)

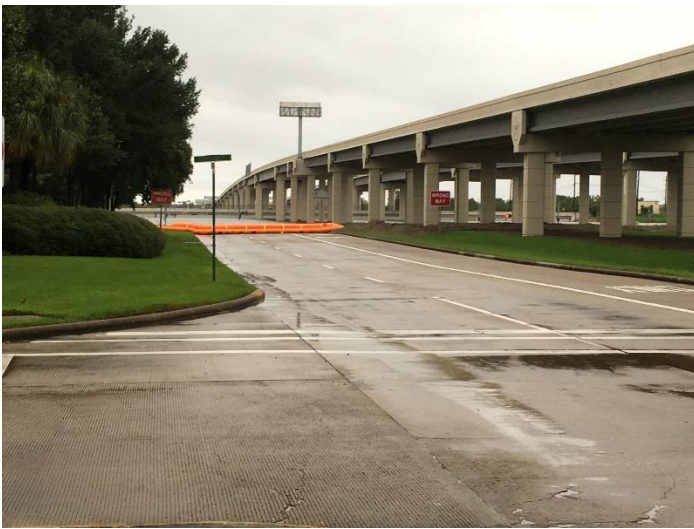
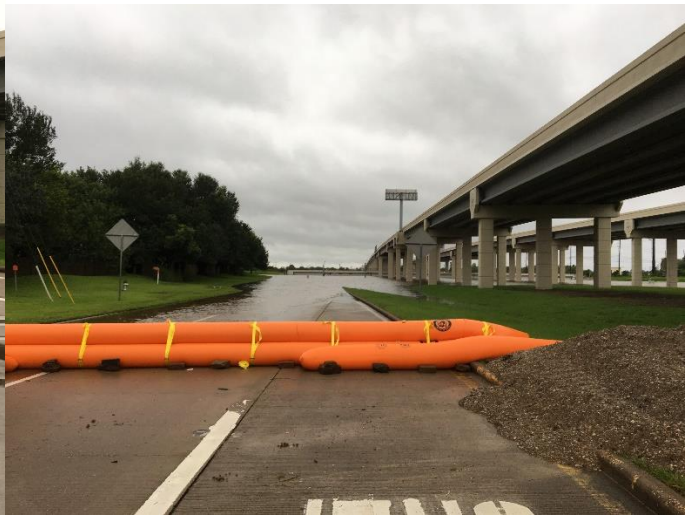
99 south bound frontage road (facing north) - Tue Aug 29

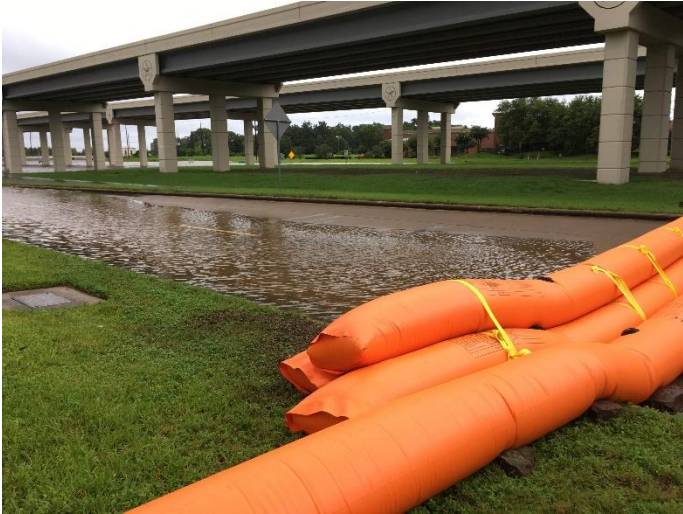
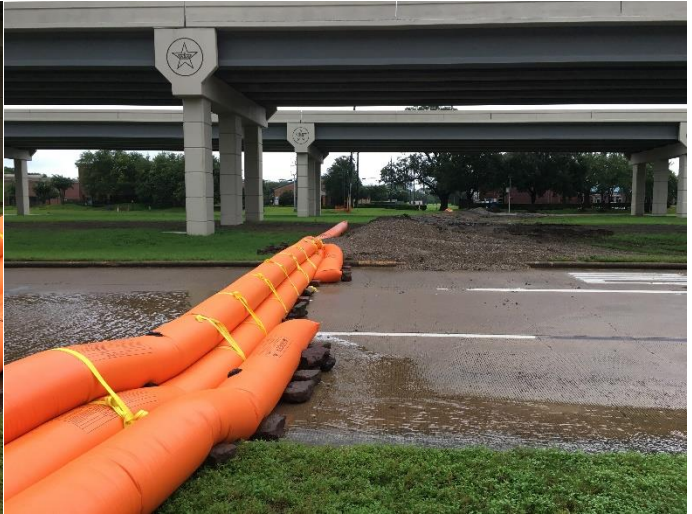
99 south bound frontage road (facing east) - Tue Aug 29

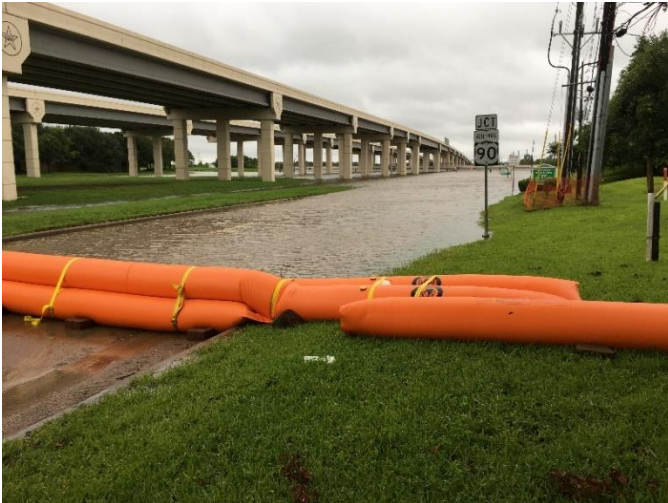
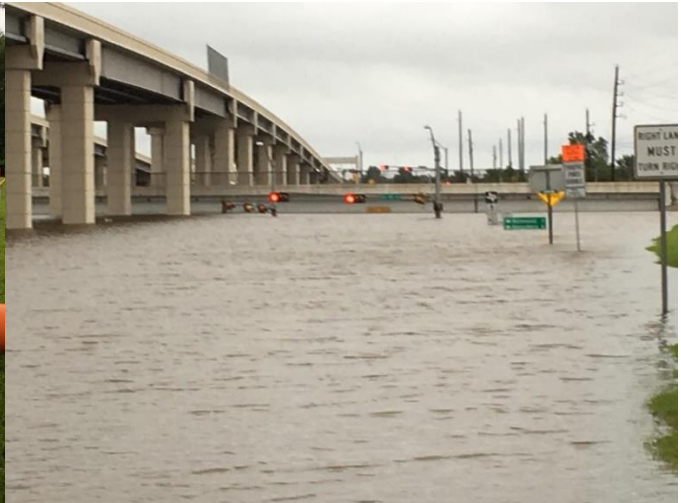
99 north bound frontage road (facing north) - Tue Aug 29

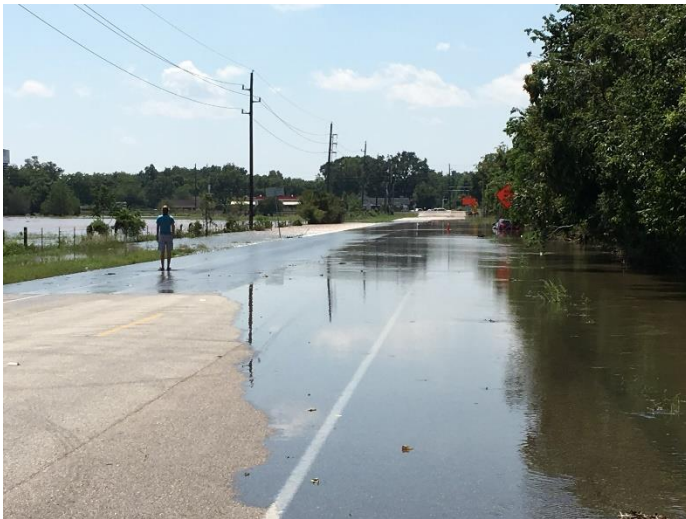
- Highest Brazos river levels reached (RG 55.2 ft.).
- 359 closed at Pecan Grove levee.
- Pitts road closed at 90 A. Moving water crossed Pitts road (west to east). Pitts may have been closed earlier.
- 90A east bound flooded and was closed. 90A west bound remained open during event.
- Harlem remains open though water extended half way across intersection at 90A. BHS back within banks.

90A & Pitts (facing south) 8-31

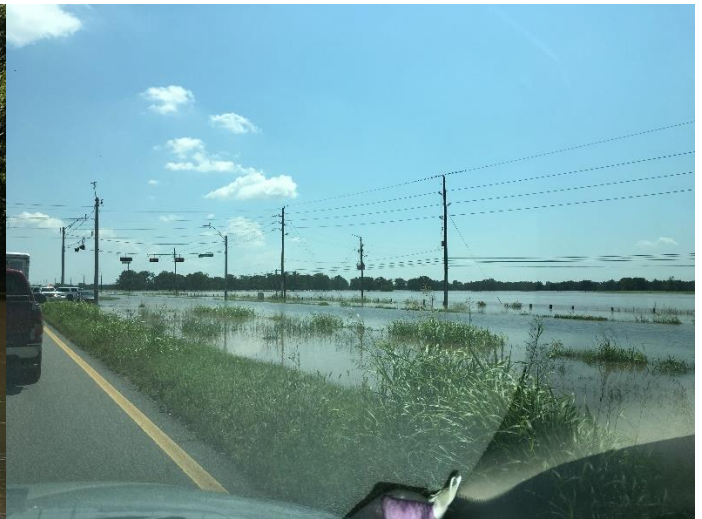
90A & Harlem (facing east) 8-31

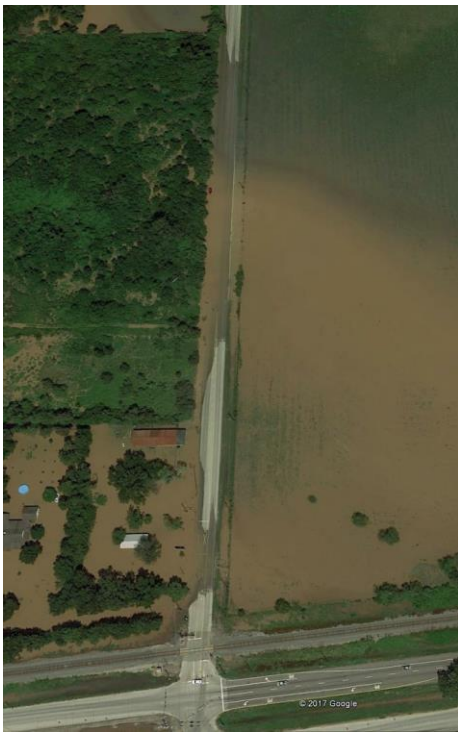
90A & Pitts 8-31-17 (elev 80 ft at cross over)

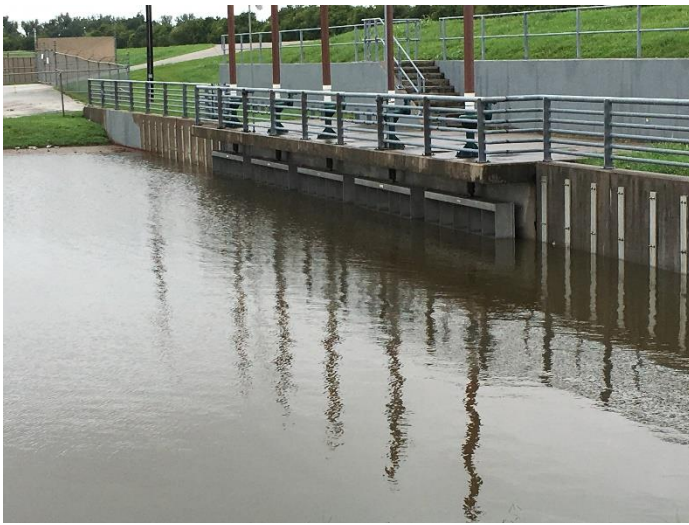
Peak water levels - Tue 8-29 10:45 AM

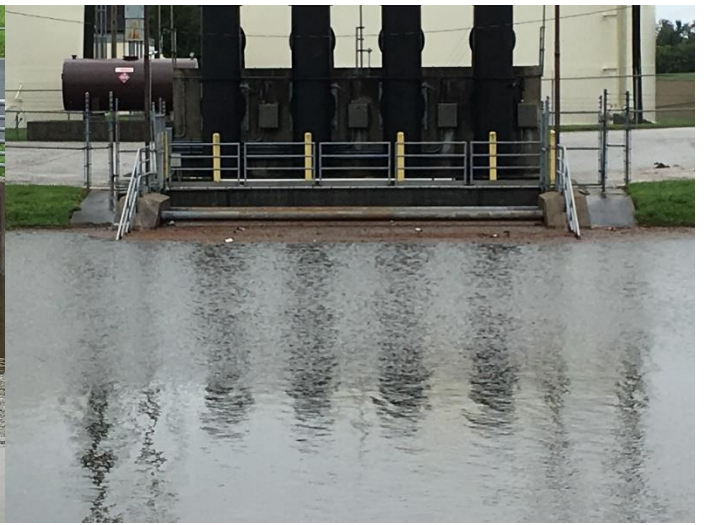
Approx. 5 ft freeboard within concrete pump box
4 x 22,000 GPM pumps

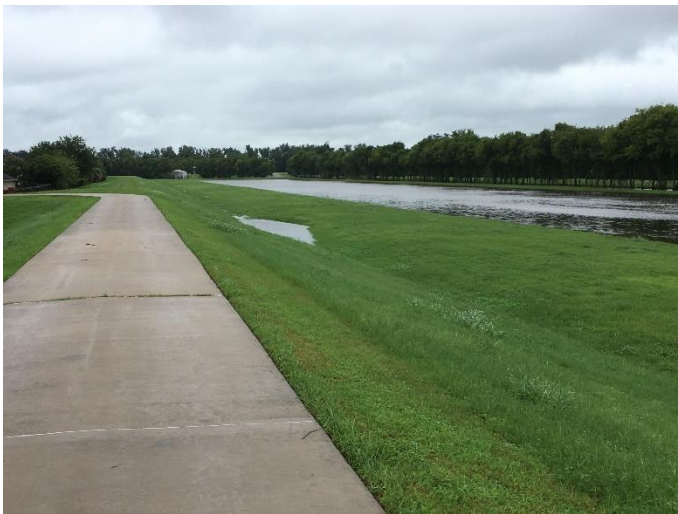
External channel (behind pump station facing S)

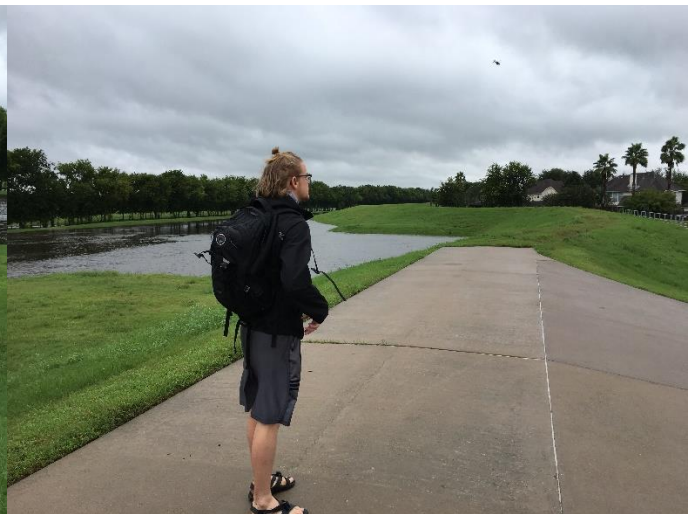
External channel (behind pump station facing N)

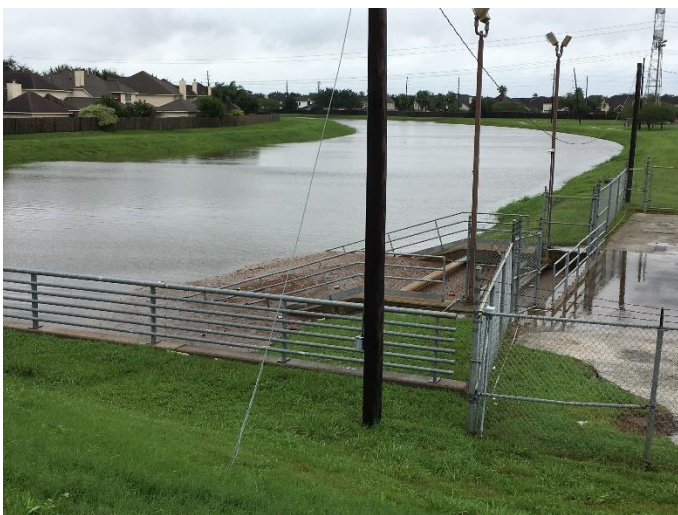
Pumps station inlet (facing east) – Tue 8-29 10:45 AM

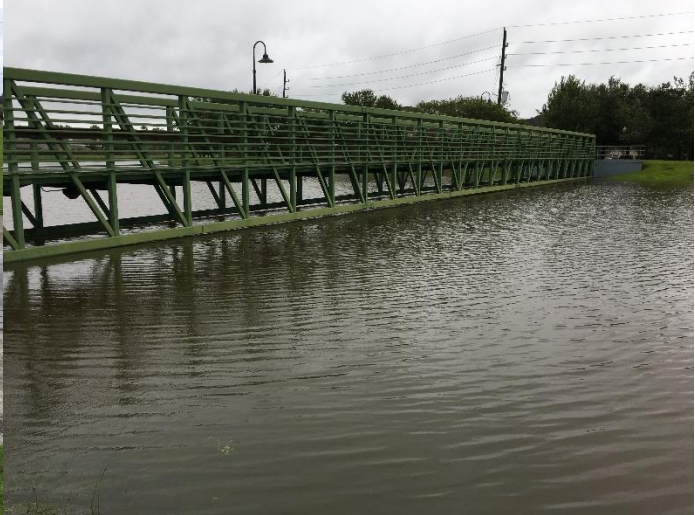
West Meadow bridge at recycled water plant.

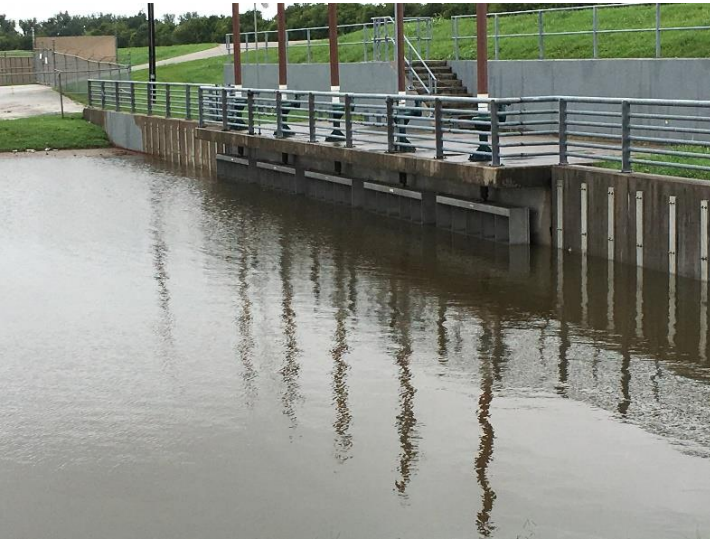
Peak water levels - Tue 8-29 10:45 AM

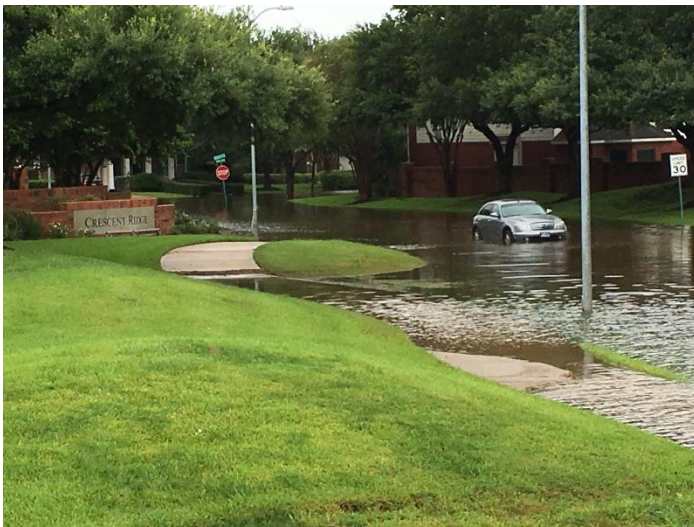
Crescent Ridge entrance.

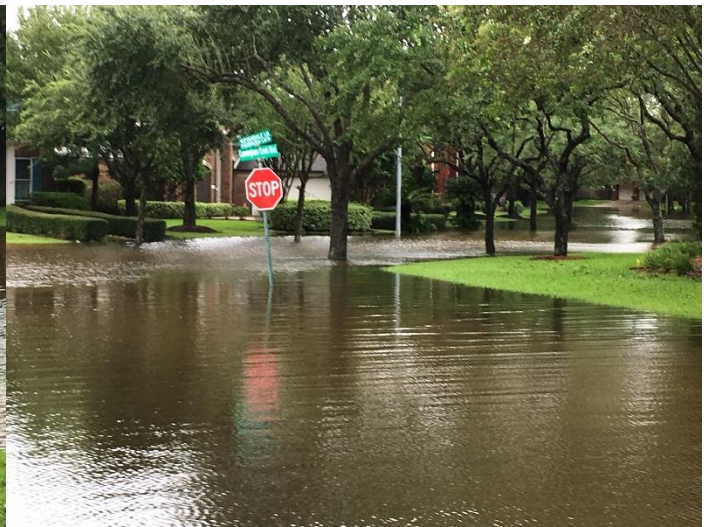
Crescent Ridge – 1st intersection (Tue 8/29 11:00 AM)
LIDAR 70.5 ft street elevation in intersection.

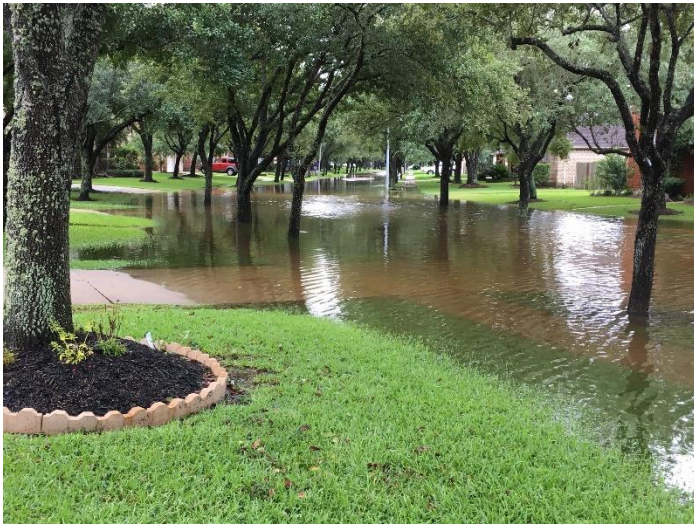
Crescent Ridge just inside entrance (Tue 8/29 11:00 AM)

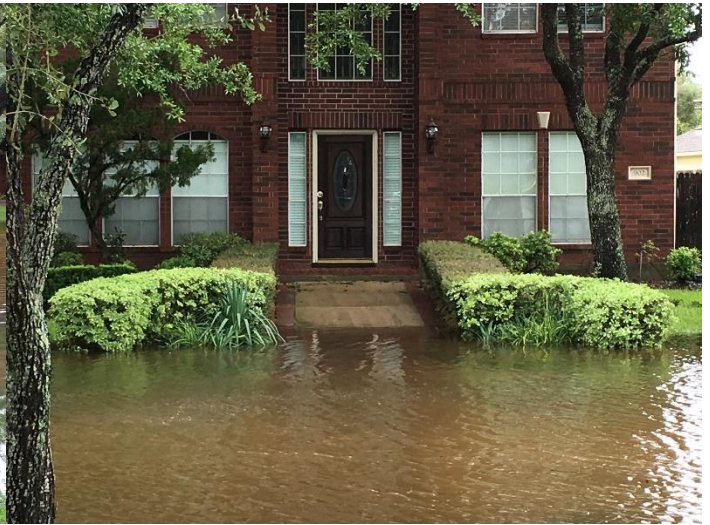
- Standing water in Crescent Ridge is most likely a result of backup from Ellis Creek. High water marks occurred approximately 36 hours after the heaviest rain falls.
- These sections of MUD 68 drain into Ellis Creek. Flood levels probably match water levels in Ellis Creek.
- Only effective way to lower water is to lower water in Ellis Creek.

HWM approx. 73 ft per LIDAR

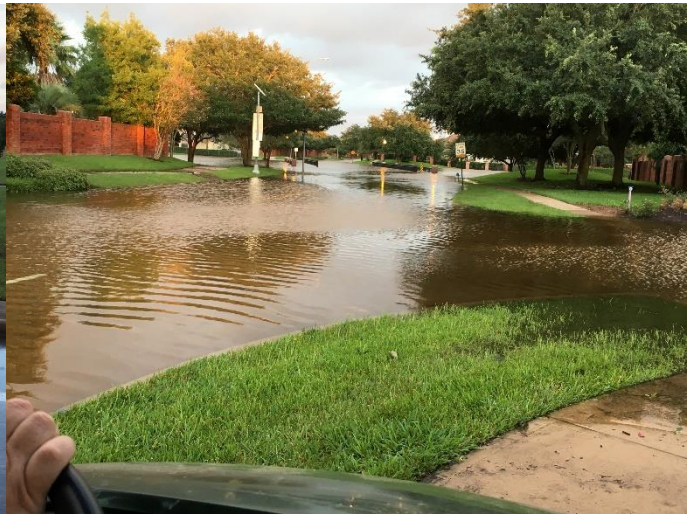
Greystone Place entrance– Tue 7:30 PM

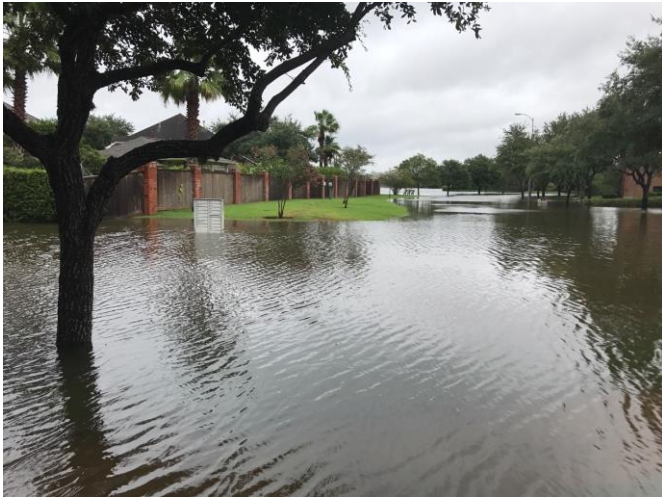
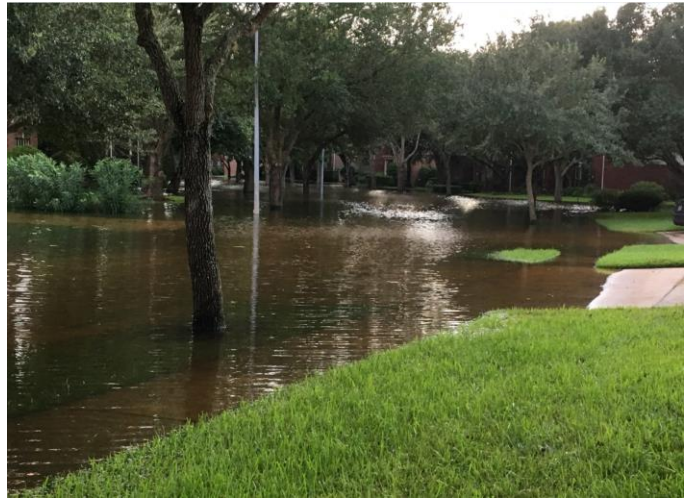
Greystone Place (1st intersection at Amberstone drive facing each direction)

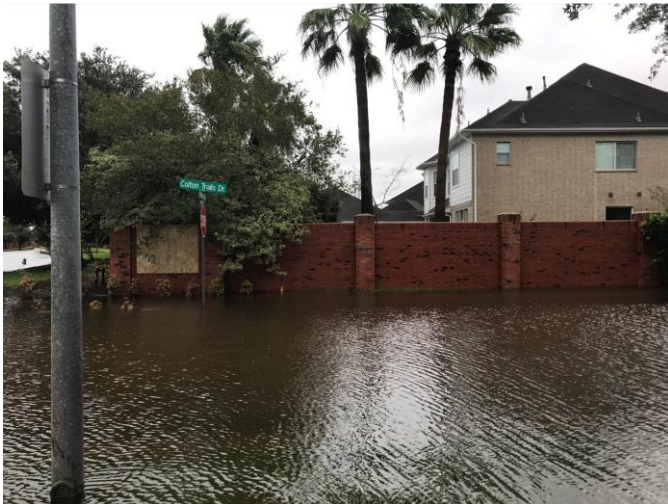
Colton Trails (HWM)

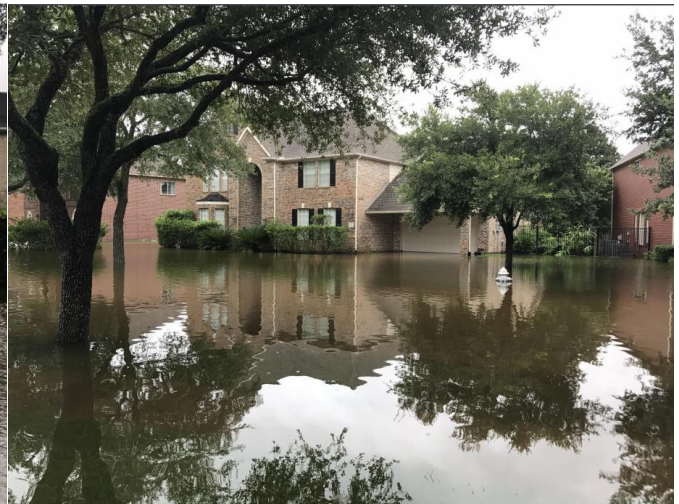
House, very close, but did not flood (12 Amberstone Dr.)

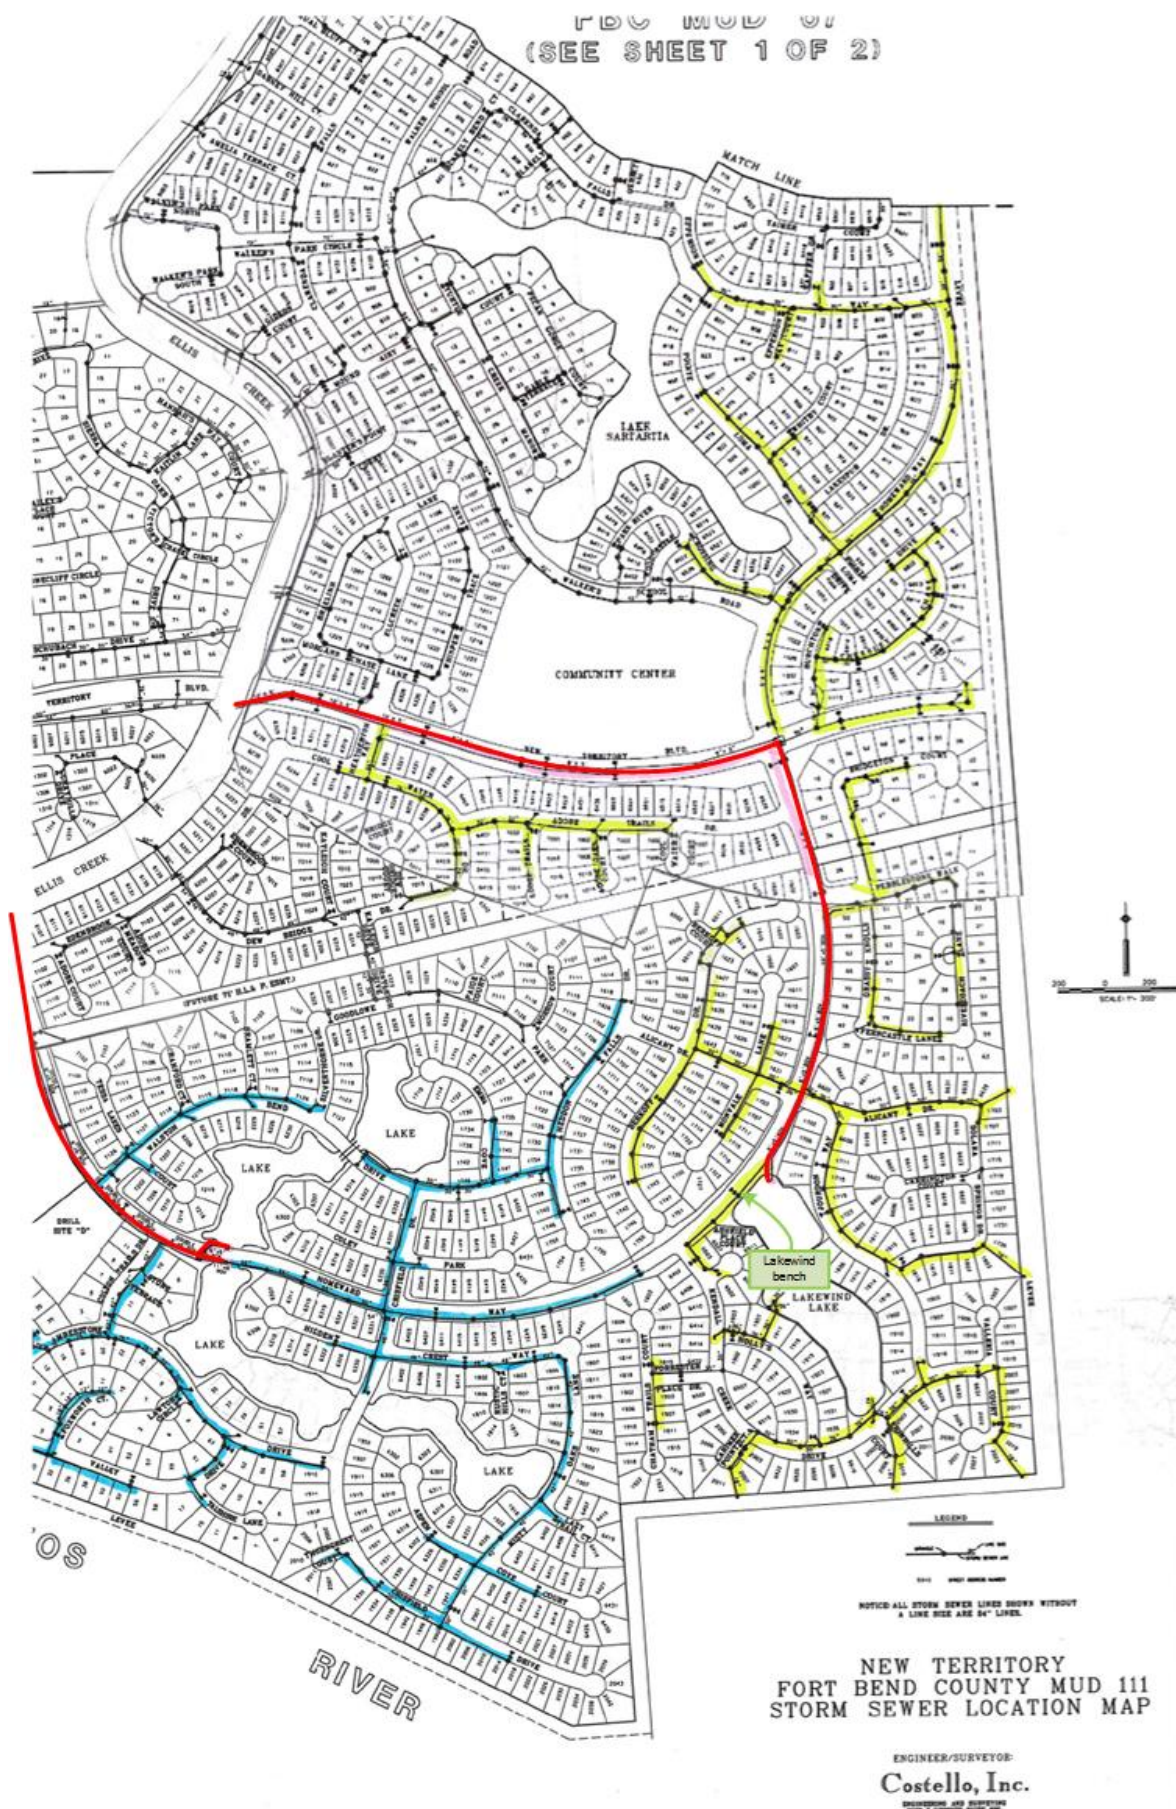
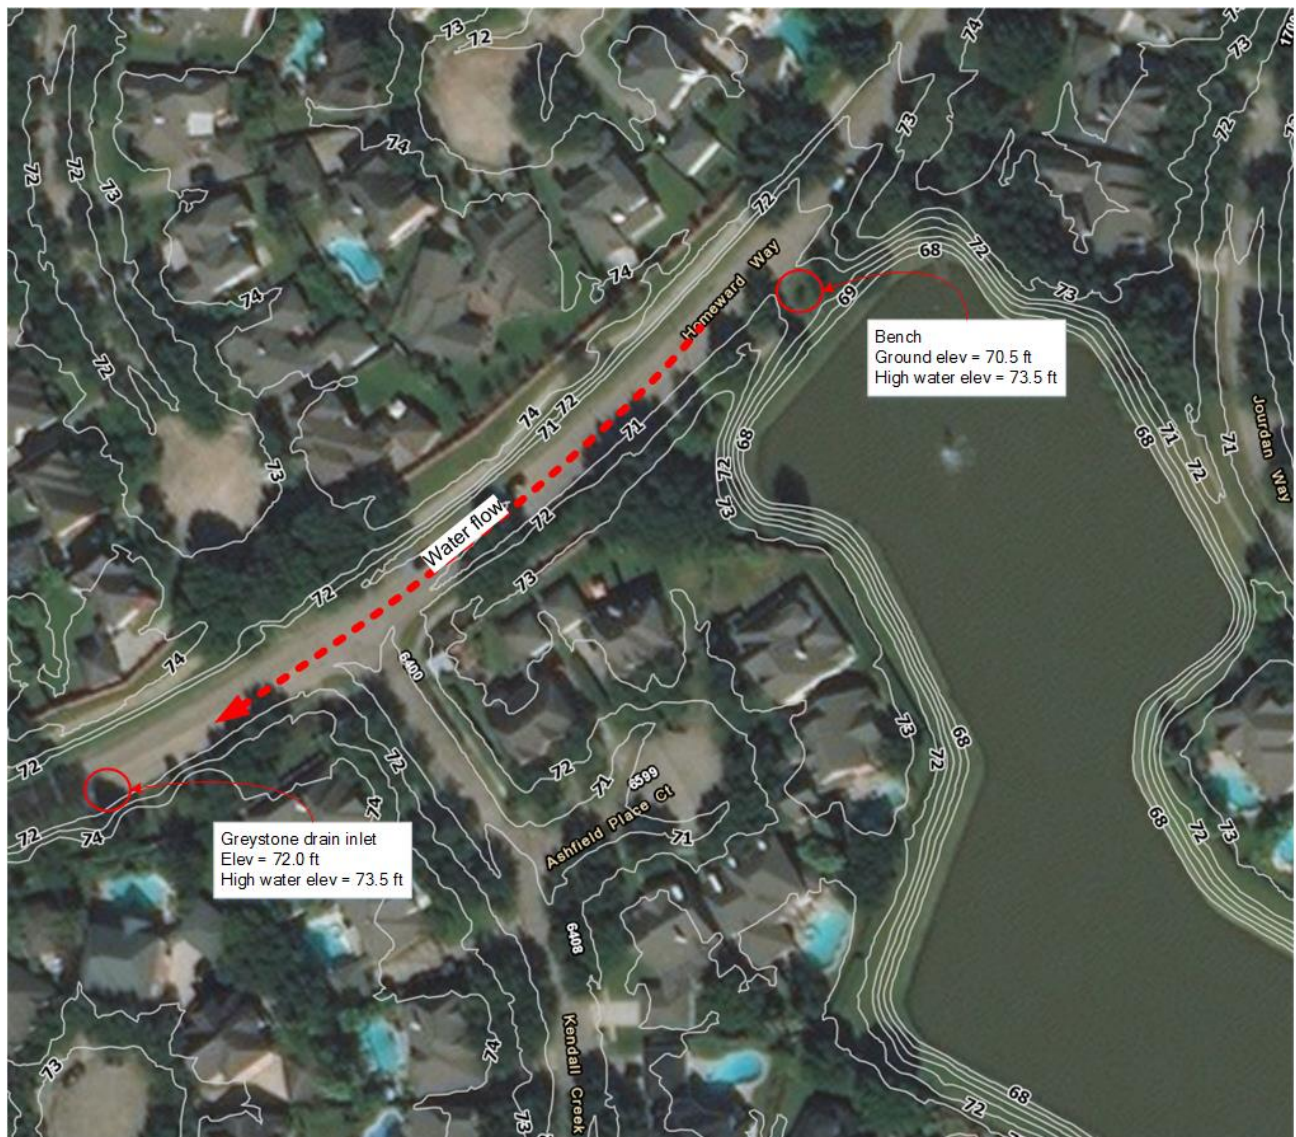
- A. Lakewind bench (normal conditions) – (LIDAR elev at bench = 70.5 ft)
 B. Lakewind home with debris line (note drain).

The Harvey high water mark (HWM) at the Lake Wind bench is approximately 1.5 ft. above the inlet drain to the Greystone / Watermill drainage system. This indicates significant amounts of water migrated into the Greystone area from Lakewind. This is a possible cause for home flooding. While it is probable that Ellis Creek water did flow back in the Greystone lakes, the elevation of the Ellis Creek waters may not have been high enough to reach home levels.
